DAMAGE IN HISTORIC RAMMED EARTH STRUCTURES: A CASE STUDY AT AMBEL, ZARAGOZA, SPAIN

Theme 2: Heritage and conservation

Key words: rammed earth, building failure, unsaturated soil

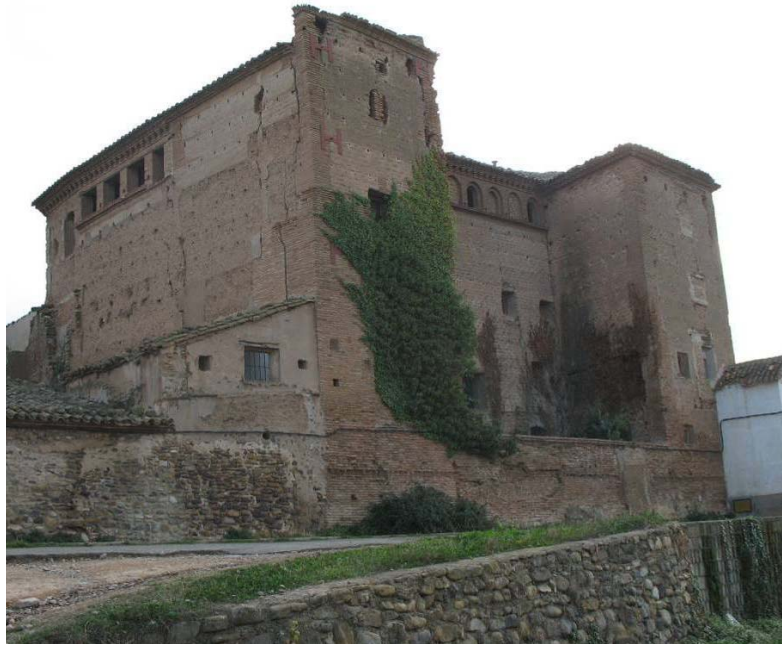
Today there are two independent sets of cracks in the east elevation (Figure 1) – two slightly inclined cracks in the centre of the building; and two vertical cracks at the north end of the east elevation, which are related to the lean of the north gable end wall. This wall leans outwards from ground level to mid-height of the second storey, with the section above this being built vertically on top of a leaning wall. The current owners of the building installed crack monitoring points in the early 1990s and this monitoring shows the continued opening of the cracks at the northern end of the tower. As a result, tie bars were placed at ceiling level at the ground, first and second storeys in 2000. These are fixed internally by bolting onto the ceiling beams and protrude externally to link to H-shaped bars on the facade which were positioned so as to overlap the brick quoins (Figure 1).

Figure 1 – The preceptory at Ambel, north-east elevation. The gallery of arches between the towers is typical of 16th century architecture in this region. The first phase precinct wall reaches the base of ivy and stands 3m high.

One feature of medieval Spanish architecture is the use of rammed earth fill *between* fired brick columns (Jaquin 2008a). Inspection of a number of such joints between the brick and the rammed earth shows that there is no structural tie between the two. Any structural movement therefore results in an opening of the joint. This is particularly a problem in later medieval architecture, where brick quoins are used, and structural movement (for example of the gable end of a structure) is unrestrained and leads to an opening of the joint. An example of this can be seen on Figure 1 immediately below the eaves at the northern end of the tower.

incisions into the rammed earth as shown in Figure 4, and as observed at other historic rammed earth sites (Jaquin 2008b). However, the eaves do not protrude on any of the faces, and this may have allowed a water flow down the face of the wall. If water is allowed to gather behind the render, then the rammed earth may become locally saturated, meaning the liquid bridges providing a bond between the render coat and the rammed earth may become saturated, causing the render to spall away from the wall (Figure 1).

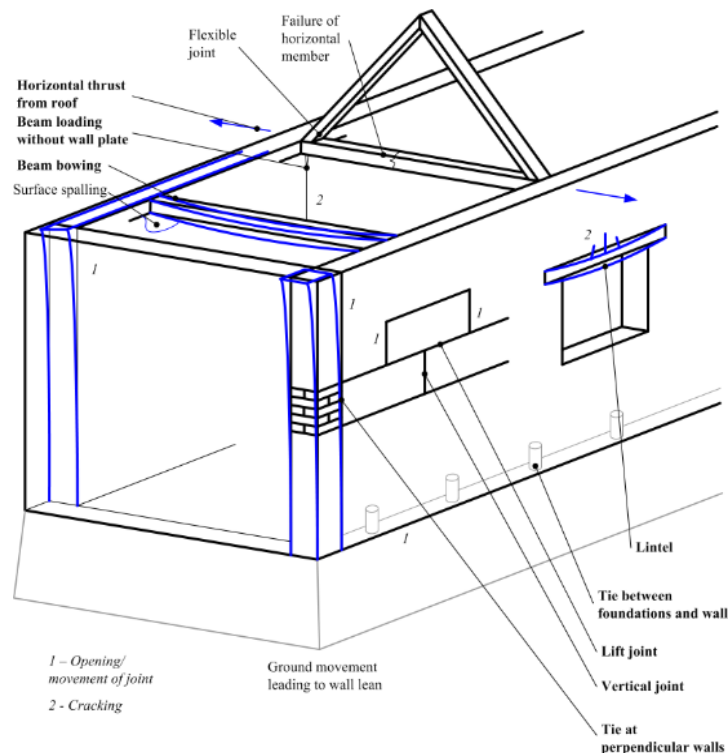
There are a wide range of causes of structural problems, including ground movement, failure or inadequacy of building elements, incorrect design, or excessive loading. This paper focuses on those issues which are felt to be specific to rammed earth. Figure 2 shows some of the mechanisms which have been identified. Potential causes of structural problems are shown in bold, while their effects are shown in a normal font. The numbers 1 and 2 in italics refer to positions where opening or cracking may occur. Three particular issues with rammed earth in Spain are identified; the interface between brick and rammed earth, joints between adjacent rammed earth blocks and transverse beams or lintels bearing onto ineffective or absent wall plates.

To prevent localised shear failure of the wall beneath a load bearing transverse beam, wall plates are used to spread the load over a larger area. Where such wall plates are absent, either through poor initial design or later alteration to the structure, there is the potential for shear failure of the wall beneath the loaded beam. Out of plane failure can also occur where a beam joining a wall is insufficiently stiff and bows under loading. This causes an increased load at the face of the wall, and can lead to spalling of the material at the face (Figure 2).

Figure 2 – Examples of failures of structural elements

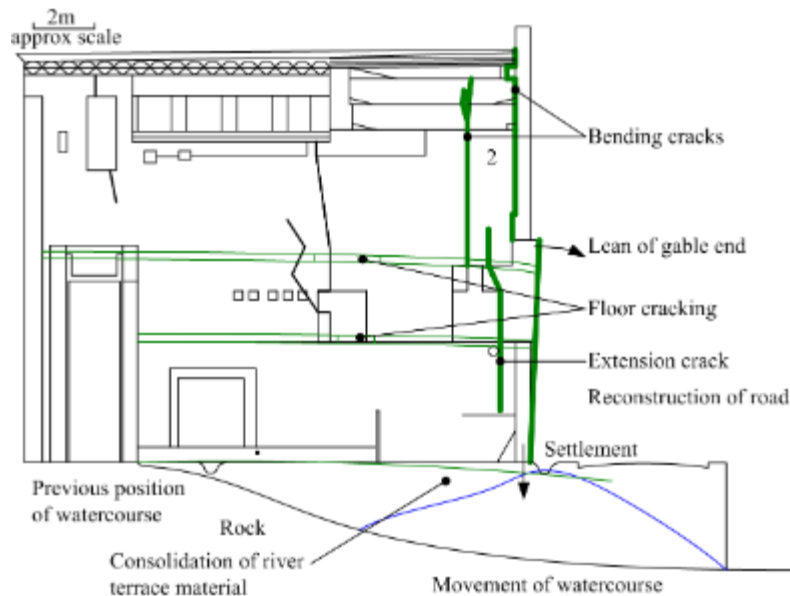
The gable end wall of the north-east granary at Ambel is showing a significant outward lean at the head of the wall, and monitoring of the cracking patterns shows that the cracks continue to open. The cause of this lean is assumed to be an ineffective retaining wall to the north of the gable wall, allowing continued settlement of the ground. The nature of the foundations of the tower is not known. As it is not currently possible to reinstate this wall, or to upgrade the road, hard intervention techniques have been used.

In the late 18th century a number of *hard* repair measures were already being enacted at to prevent collapse of the leaning north wall. There is no structural tie between the rammed earth north and east walls, and the brick quoin at the corners. As described above, a further storey tower may have existed at the north of the granary, and this tower may have provided a structural tie between the gable end and the transverse walls. Analysis of the architectural fabric suggests that timber buttressing was placed against the external wall, and repairs were carried out to the ceiling arches at each floor. In addition, battens were embedded at the north end of the east and west walls, spanning to the leaning north wall. Their effectiveness is questionable, as cracks are present in the wall at the south end of these timbers. This indicates that the timbers may have succeeded in stiffening the north end of the structure, but because ground movement has not been halted, further deformation and cracking has occurred. In 2000 H-shaped spreader plates were fixed to the face of the wall, which are affixed to 150 mm x 80 mm I-beam sections running through the length of the building. These I-sections are bolted to the transverse ceiling timbers at each side of the building at ground, first and second floor levels.

Although this intervention follows sensible principles, it may be noted that the horizontal component of the lean of the gable wall is transferred directly to the transverse timbers through bolting, which maybe prove unsatisfactory, with the bolts shearing from the timber with increased horizontal load from the gable wall. Monitoring of crack growth shows that the placement of this system has not arrested the growth of the cracks, suggesting that it is yet to engage or is proving ineffective. Future work is now being suggested which will involve the placement of spreader plates on the outside of the south wall, allowing the I-beam sections to span the whole length of the building and thereby stiffen the whole structure.

Where the cause of the structural problem has been mitigated, then a *soft* repair of filling of the cracks is recommended. This will not only improve the appearance of the building but also prevent water ingress. At Ambel, cracks in the centre of the long east wall are thought to have formed prior to the movement of the gable end, and have therefore been filled. The filler is brick, which would originally have matched the scored rendered original face of the rammed earth, although this is now removed. Filling with similar fallen material in rammed earth is problematic, though the *column method* is recommended by Pearson (1997) and other possibilities are suggested in Jaquin (2008a).

Reinstatement of the roof of the granaries occurred around the same time as the late 18th century repairs. At one location this involved the introduction of a transverse timber beam which carries a large proportion of the roof loading into the south gable end wall. This timber is causing in-plane cracking of the rammed earth wall because of the lack of a wall plate.

Figure 3 – Cracking patterns and causes, east-facing elevation of the north-east tower at Ambel

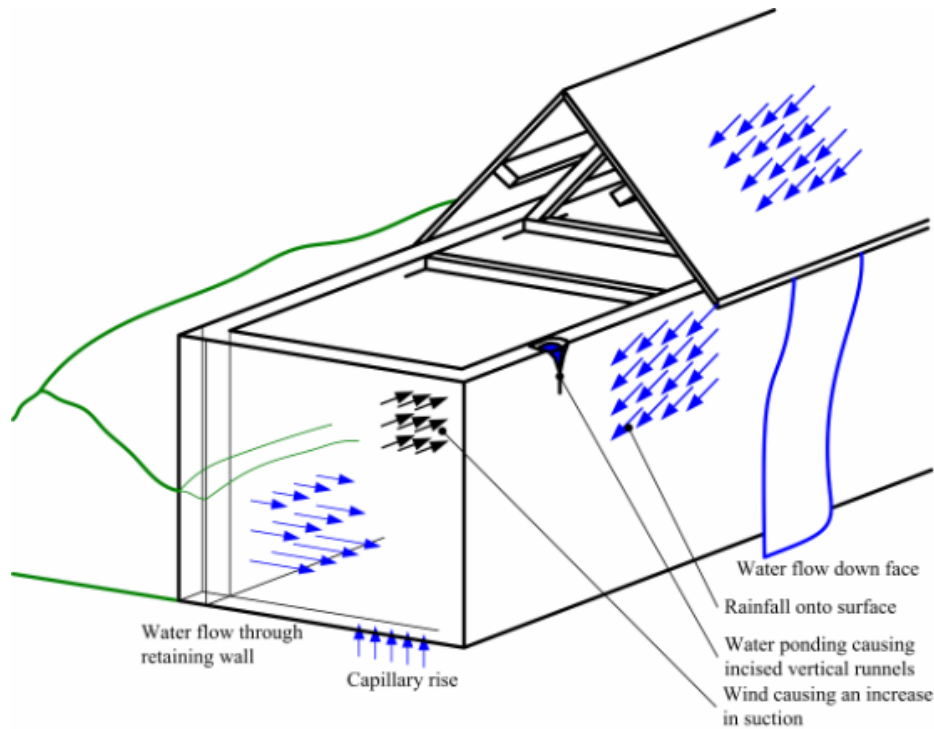
their strength. It is proposed that water running over the surface of a wall, allowing constant infiltration causes erosion of rammed earth. Damage to unstabilised rammed earth caused by water is a result of it becoming saturated. A number of mechanisms by which water can enter a structure are shown in Figure 4. This paper argues that it is the *magnitude* of the water infiltration which causes damage to rammed earth.

Water *does* pose a problem for unstabilised rammed earth structures where it is allowed to flow down the surface of a wall. This usually happens where it is allowed to gather (pond) at the head of a wall, and flow down the face. Because of the larger volumes of water involved, the rate of water infiltration overtakes the rate at which water is removed from the wall by evaporation, and so a drip forms on the surface of the wall. This may allow the surface of the rammed earth to become saturated, and for soil particles to become suspended within the liquid and flow. This mechanism can be seen in the formation of worm cast type structures where material has first flowed into a slurry, then dried to leave mounds of fine material on the wall face. The presence of these structures indicates the downward movement of material and is thus indicative of past water flow. The likely cause of the formation of the structures is the slow downward movement of water down the face of a wall, for example a drip which is able to pick up material and transport it in solution down the wall, until such a point as the drip evaporates and the material is returned to the wall. Inspection of these structures indicates that they contain only very small particles, as it is only these which may be picked up by the water. The rate of infiltration of water into the body of the wall is sufficiently slow that the drip of water is able to continue down the face of the wall, saturating and therefore picking up smaller soil particles, before all the water is absorbed by capillary action into the wall and those smaller soil particles redeposited. If the rate of water flow is increased, such as by an ineffective drain, then larger soil particles and larger volumes of material are picked up by the water flow, and incisions form in the vertical face of the wall (Figure 4). This mechanism involves the movement of material down the wall causes a deterioration of the structure.

Figure 4 – Causes of damage by water

Repair of rammed earth walls damaged by water should only be attempted when the cause of the water flow has been addressed. It has been argued that the main repair strategy for water damage is reinstatement of the head of the wall to prevent further water flow down the face. This has taken the form of concrete ring beams for the restoration of the towers at Biar and La Rambla (Jaquin 2008a) or as bamboo matting at Ait Ben Haddou in Morocco. If it is possible, then the roof of the structure must be reinstated, and the drainage from this correctly positioned.
