DAMAGE ASSESSMENT OF HISTORIC EARTHEN SITES AFTER THE 2007 EARTHQUAKE IN PERU

Theme 3: Heritage and Conservation

Key words: Earthen Architecture, Earthquakes, Seismic damages, Damage assessments.

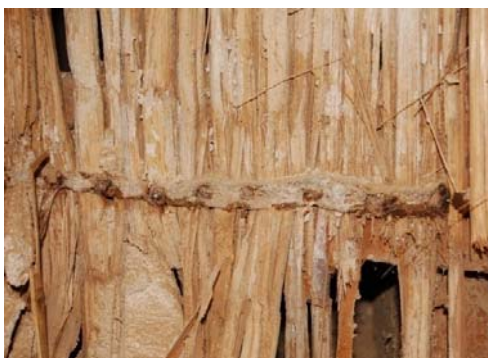
Most of the visited sites damaged by the earthquake were constructed with domes, vaults and walls made of *quincha*. Regular maintenance of these structures was expected during the Peruvian ancient and colonial times, including the occasional replacement of the wooden structural elements, cane reed and leather straps. With time and lack of maintenance, wooden elements were damaged by the presence of termites and the connections started to fail. The leather straps became brittle and the reed cane detached from the structure losing its flexibility and tensile strength. The state of deterioration of this construction system influenced the way buildings performed during the Pisco earthquake (Figure 2).

Figure 2: State of deterioration of Quincha panel at the Cathedral of Ica
(Credits: INC Lima, 2007)

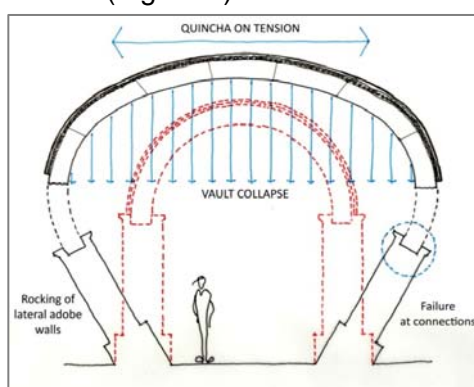
As mentioned before, wooden structural elements and the cane mesh of the *quincha* were heavily damaged by termites. In the case of the vaults, the damage was observed at the wooden arches and at their connections to the top of the adobe walls, pilasters and front facades. Another pre-earthquake condition contributing to collapse is the presence of a heavy layer of dirt or cement mortar over the vault, probably due to lack of or inappropriate maintenance respectively. At the moment of the earthquake, the vault tried to restrain the rocking of the walls, adding stress to the deteriorated trusses and their connections until failure (Figure 3).

Figure 3: Failure scheme mode of quincha vault. (Drawing, C. Cancino, 2007)

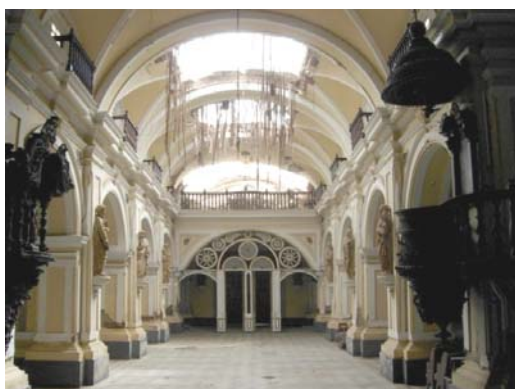
At the churches of Coayllo, Guadalupe and Humay, the presence of reinforced concrete arches at the end of the vaults stiffened the structure at both ends which in conjunction with the deteriorated arches induced the *quincha* vault to fail. At the Cathedral of Ica, the architectural configurations of the building as well as its maintenance helped to partially withstand the earthquake. The better seismic performance of preserved arches, the presence of the lunettes and side chapels between them prevented the total collapse of the vault (Figure 4).

Figure 4: Cathedral of Ica after the Pisco earthquake where arches and lunettes stopped total collapse of quincha vault. (Credits: J. Paul Getty Trust, 2007)

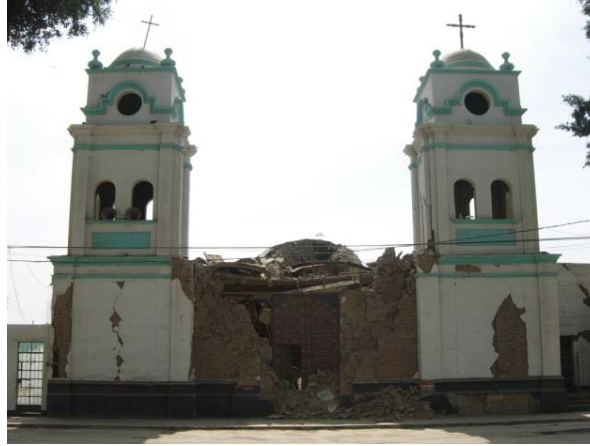
When entire vaults or domes collapsed, it was clear that walls (front facades or lateral walls) rocked until connections failed resulting in partial or total vault collapse. In the case of the Church of Guadalupe the concrete tower pounded the earthen façade until collapse of its upper section inducing partial collapse of the vault (Figure 5).

Figure 5: Church of Guadalupe after the Pisco earthquake where out of plane collapse of front facade induced partial collapse of the quincha vault.
(Credits: J. Paul Getty Trust, 2007)

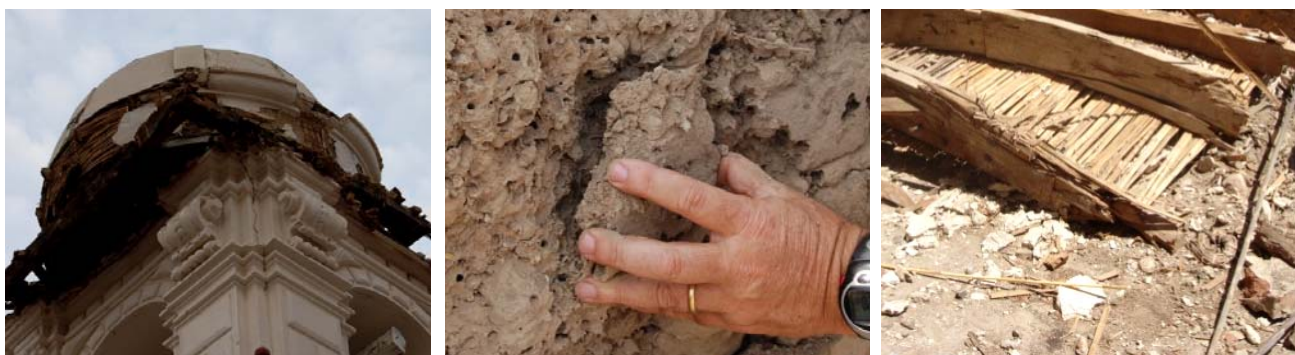
- Loss of structural integrity and lack of connections between damaged wooden elements of *quincha* vaults, pillars and walls, which isolated parapets, partitions, and façades, affecting their stability. (Figures 6, left)
- Non-repaired structural cracking and weak mortar-block adhesion strength.
- Moisture damage to the *quincha* and adobe walls.
- Beetle damage in adobe blocks that reduced wall strength. (Figure 6, center)
- Termite damage on the wooden framework of the *quincha* walls, which contributed to partial or total collapse of entire structures. (Figures 6, right)
- Addition of different building materials and systems into the structure.

Figure 6, left: Upper dome of Hacienda San Jose Chapel where connections deteriorated inducing loss of structural integrity. (Credits: J. Paul Getty Trust, 2007)

Figure 6, center: Sample of beetle damage at the adobe walls at the worker residences of the Hacienda Arona y Montalván. (Credits: INC Lima, 2007)

Figure 6, right: Wooden trusses damaged by termites at the San Jose Church. (Credits: INC Lima, 2007)
