# SEISMIC RESISTANT ADOBE WALLS AND EARTHEN FRAMEWORK VAULTS AT THE COMPAÑIA DE PISCO CHURCH IN PERU

Pedro Hurtado Valdez

Theme 7: Ancient/Historic and Innovative Solutions for Damage Prevention and Performance Improvement  
Keywords: Dome, earth, seismic

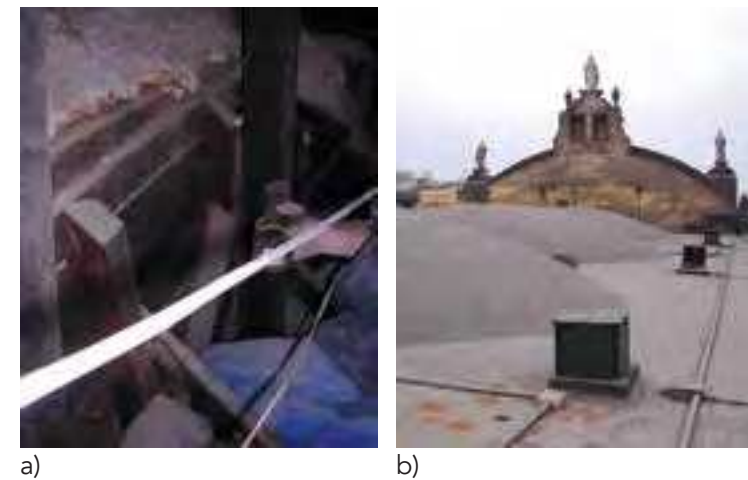
Fig.1 Lima's cathedral vaults: a) Soffit; b) Extradados (credits: Pedro Hurtado Valdez, 2007)

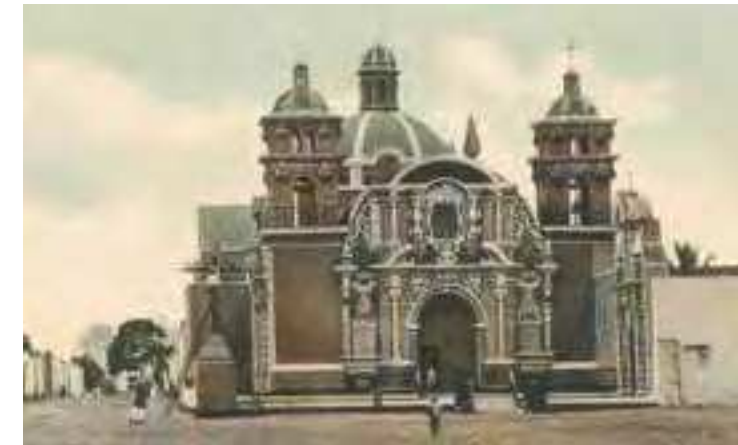
Fig.2 The Compañía Church, in Pisco: a) In 1920, the church had endured the great earthquakes of 1746 and 1877 without collapsing; b) By 2007, before the earthquake, the building had a cement floor, and the paved streets prevented earthen substrate from expelling vapor (credits: Domingo Canepa, 1920; Pedro Hurtado Valdez, 2007)

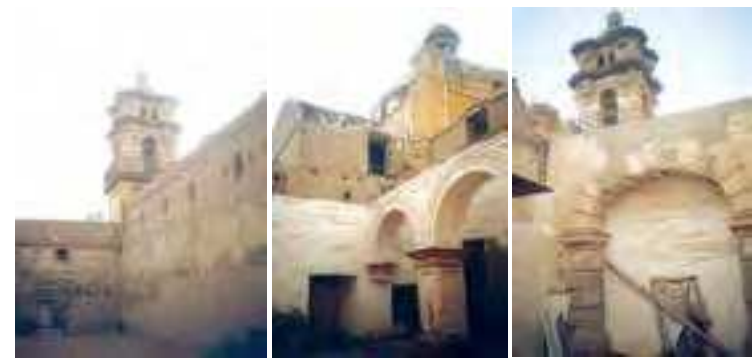
Fig.3 The *Compañía* Church, Pisco: a) Adobe walls coated with cement at the bottom; b) Earthen-framework vault and dome left weathering without an earthen coating; c) Adobe arch with cementitious-coating renovation (credits: Pedro Hurtado Valdez, 2007)

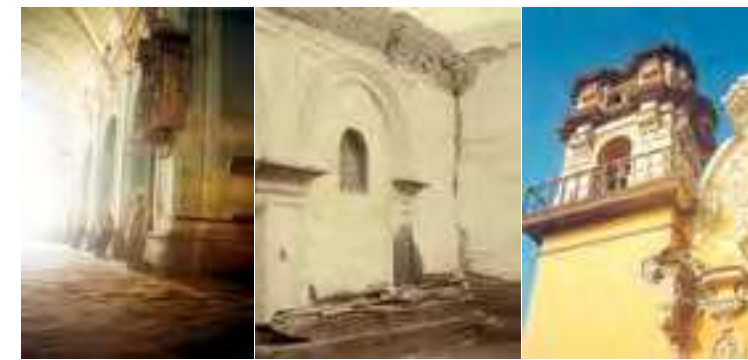
Fig.4 The *Compañía* Church, Pisco: a) Adobe walls with humidity and differential settlement; b) Adobe walls with loss of the original locking elements and the ties between themselves; c) Crack separating the walls of the tower and façade of the nave (credits: Pedro Hurtado Valdez, 2007)

Up until that time, there was a marked deterioration of the walls from the continuous and accumulated damage of earthquakes in the second half of the 20<sup>th</sup> century, which had not been repaired. Most of the walls were cracked and separated from each other, making their slenderness increase significantly. Consequently, during the seismic action, each portion of wall acted independently in motion, colliding with each other.

In addition, the walls were sealed with cementitious products, as was the pavement of the patio annex to the temple, and the streets with asphalt. This produced high moisture content in the subsoil, which rose by capillarity up into the walls of the church, causing the moisture content inside the walls to be high, resulting in the softening of the adobes and loss of their bearing capacity.

With increasing humidity, the saline soil on which the church was founded led to the migration of salts and their subsequent crystallization within the walls, causing micro-fractures within them. Also, the wooden elements inside the walls, while in a moister environment, were attacked by wood-eating insects and decay fungi, and thus unable to provide ductility for the walls.

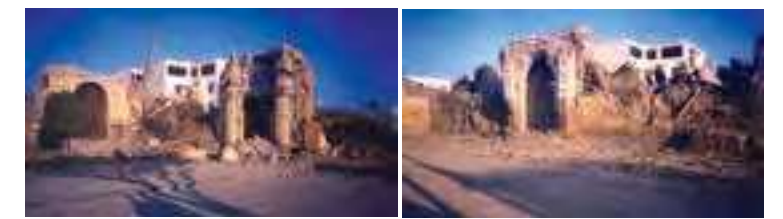
The collapse of the earthen framework vault was due to factors related to the state of conservation of the structure. This was firstly motivated by the sharp deterioration of the walls on which the vaults were supported, which, during the earthquake, could not withstand the thrusts, overturning at the top and leaving the locking elements (*encadenado*) without support.

As for the second cause, it was due to the deterioration of the vault wood and cane elements. As the coating had not been maintained, the locking elements and the *camones* had been

Fig.5 The *Compañía* Church, Pisco in 2007 after the earthquake: a) Area of the main façade and the entrance to the school, already separated from the rest of the wall pre-earthquake; b) Lateral façade also with separation cracks (credits: Pedro Hurtado Valdez, 2007)

exposed to the weather and showed attack from wood-eating insects and fungal decay. Having lost many of the pieces of the original vault, its central section had diminished mechanical ability. In addition, the leather straps had loosened, as the wooden pieces lost their consistency and the nails rusted. As the trusses are not continuous elements, and instead obey the effects produced by the rotation of the joints in the *camones*, stability was left compromised (Marzo, 2006). Equally, cane enclosures were in an advanced state of decay, and the gypsum plaster seemed to have exceeded its saturation capacity to water vapor, thus beginning to transmit even more moisture to the trusses. During the 2007 earthquake, trusses failed in the central area, incapable of controlling the rotation of the *camones*, while in the area of the *camones* abutments tended to rise, but without dissociating from the locking elements, and thus maintaining stability (15).
