# CONSERVATION OF ANDALUSIAN MONUMENTAL HERITAGE: THE CASE STUDY OF THE NIEBLA WALLS IN SPAIN

Jacinto Canivell, Ana González-Serrano

Theme 7: Ancient/Historic and Innovative Solutions for Damage Prevention and Performance Improvement  
Keywords: Assessment, risk, conservation, vulnerability

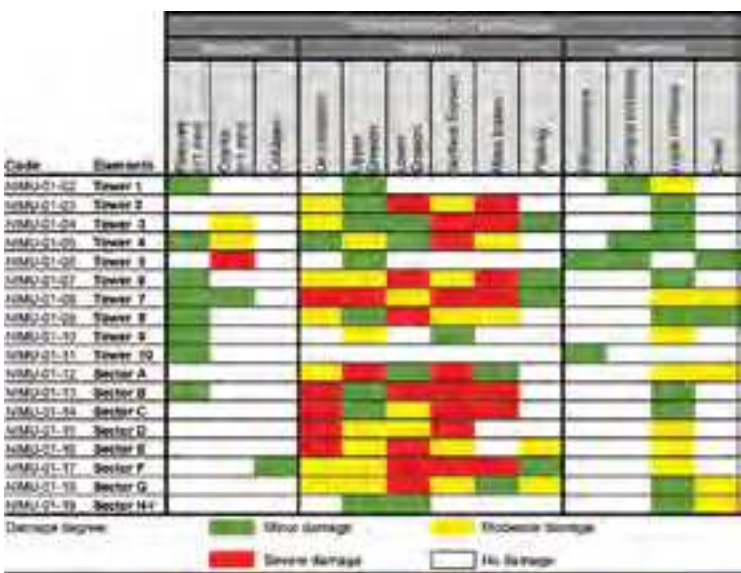
Table 2. Damage characterization of Niebla wall between Towers 1-10 (credits: J. Canivell, 2011)

The characterization of damage is based on an in-situ methodology of visual and organoleptic analysis (Canivell, 2011), and supported by graphic documentation. Due to the constraints of the selected sections, it has only been possible to analyze one side of the rammed-earth masonry, as the other belongs to private plots with restricted access. As described in Table 2, the characterization of damage has been categorized into three groups according to the severity.

In addition, damage is assessed at three levels that are color coded, taking into account the spread of damage and its severity. It should be added that the purpose of this evaluation is to specify corrective measures for the existing damage.

Structural damage: This is linked to processes that affect or could affect the structural stability of the work. There are many forms of this damage; however, only those showing obvious signs of deterioration were considered. Therefore, fissures and cracks were evaluated, whether active or inactive, being in almost all cases of vertical orientation, possibly due to the curing shrinkage of the mass or thermal variations. Collapses refer to the loss of verticality in the wall. In this case there are no collapses of entire sections of the original wall; however, some layers of rammed-earth restored to one side show signs of collapse. As depicted in Table 2, structural damage has had little impact in this sector and, therefore, there was no need to undertake this type of corrective measure.

Materials damage: These include the damage affecting the integrity of the rammed-earth mass. Lack of consistency is a very clear sign in the restored layers of rammed-earth, which disintegrates with a simple touch of the hand. This rammed earth appears to be of irregular compaction, resulting from insufficient control of the work, in light of the inclusions of large stone blocks, fired bricks and even organic materials. In general, erosion is typically caused by external agents (moisture, wind-driven rain, temperature, and fauna). Severe erosion is found in the highest lifts of rammed earth, which is more susceptible to moisture infiltration and the effects of wind. Erosion at the lower parts of the wall is often linked to capillary rise, or the backsplash of water against the wall at the lower lifts. Surface erosion is generally spread and is normally caused by the continuous washing of rainwater. In the sections studied, erosion is aggravated by the accumulation of water in certain obstacles (joints, weep holes), producing cavities. Mass losses, although sometimes confused with erosion, have a different origin. The poor quality of the rammed-earth is the cause of these types of detachments, also aided by other external agents, showing more severity in Sections B, C and F. Finally, a special mention is made of flaking as a singular condition, through which the mass of the wall disintegrates in slab-like shapes, parallel to the façade.

Generally, damage to the integrity of the mass has deteriorated the rammed earth with greater severity in the sections studied, due to the exposure to the southwest (the predominant direction of winds and rains), and the low quality of the restoration rammed earth (particularly between T1 and T7). In certain sections (T7 to T10), the quality of the rammed earth dramatically improves (3), even though its exposure similar.

Superficial damage usually affects only shallow layers of rammed earth and can lead to erosion. The efflorescence that shows up as surface deposit of salts is difficult to identify on rammed-earth masonry and even more so, if it is eroded. However, small deposits have been observed in some stone areas and towers. The uniform soiling is linked to the existence of an aggressive environment with a high proportion of suspended particles, causing a widespread contamination of the wall. Local soiling is caused by the differential water-washing of the wall, causing staining typically at the top of the wall, or at intersections between walls and towers. These dirt crusts are a result of the accumulation of muddy moisture and the development of fungi and lichens, forming thin harder surface layers, which when detached, leave a weakened rammed earth exposed to the outside environment.

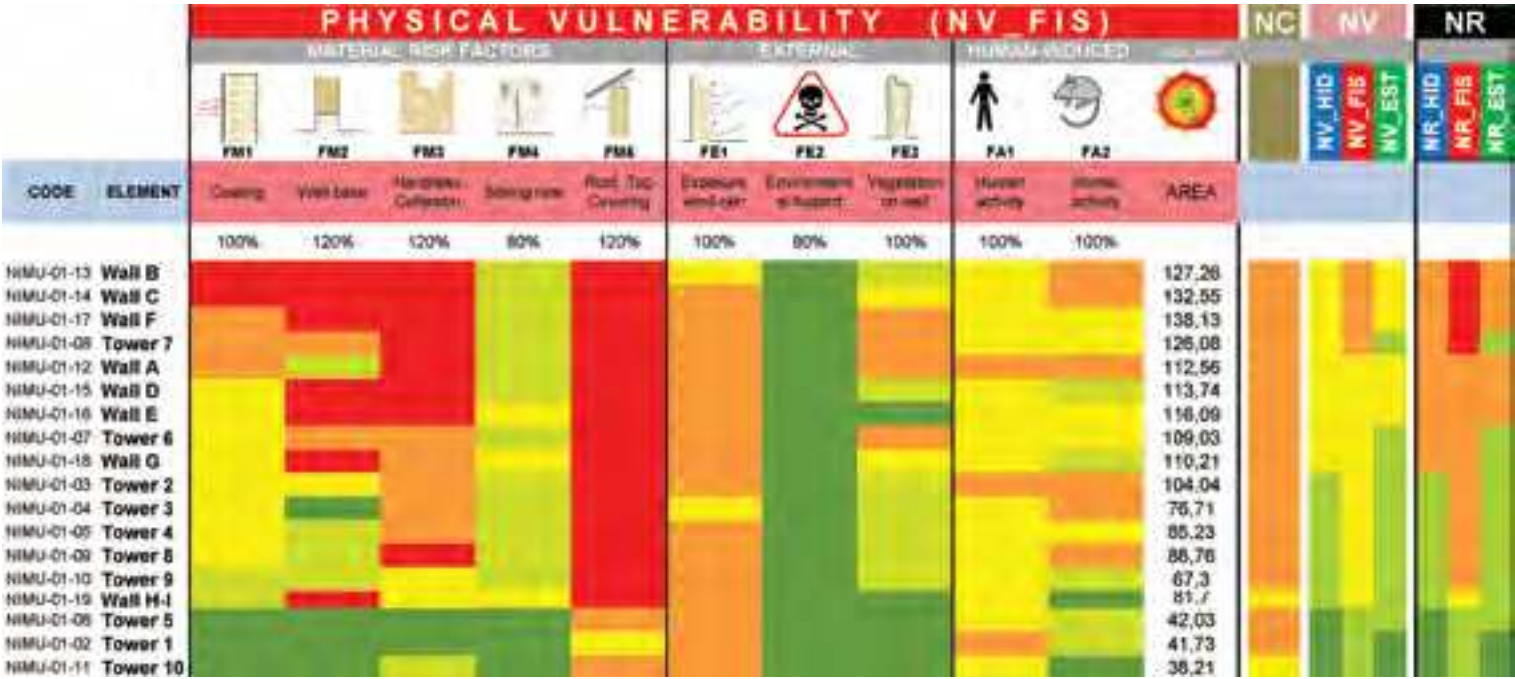
Table 3. Table of risk factors of physical vulnerability to NP (left), NC, NV and NR (credits: J. Canivell, 2011)

Vulnerabilities of rammed-earth masonry are set first: the hydric, the physical and the structural vulnerabilities, which define pathological processes of uncontrolled water access; erosion, loss of mass and cohesion; and structural stability; respectively. In order to characterize the three vulnerability types, three groups of risk factors were designed, which in turn were classified as external (circumstances outside the masonry), materials-related (in reference to properties or states of the same masonry), or anthropic (external, but with human-activity origins). Like the INSHT system, each factor was evaluated according to its amount of exposure (Level of Exposure: NE), based on a predesigned scale of five levels, from very low to very high northeast exposure.

Nevertheless, it is necessary to note that not all risk factors may have the same weight in defining the state of vulnerability. To this end, evaluations were introduced into the assessment, the so-called Deficiency levels (ND), establishing approximately the probability that a given risk factor is a source of damage. ND accommodates each case study, so the methodology is open

and adaptable. By cross-referencing the values of NE and ND, the Levels Probability (NP) are obtained for each risk factor within each of the three vulnerability types. However, although a general reading of the state of the element can be had, as shown in Table 3, there is no value that characterizes a vulnerable state.

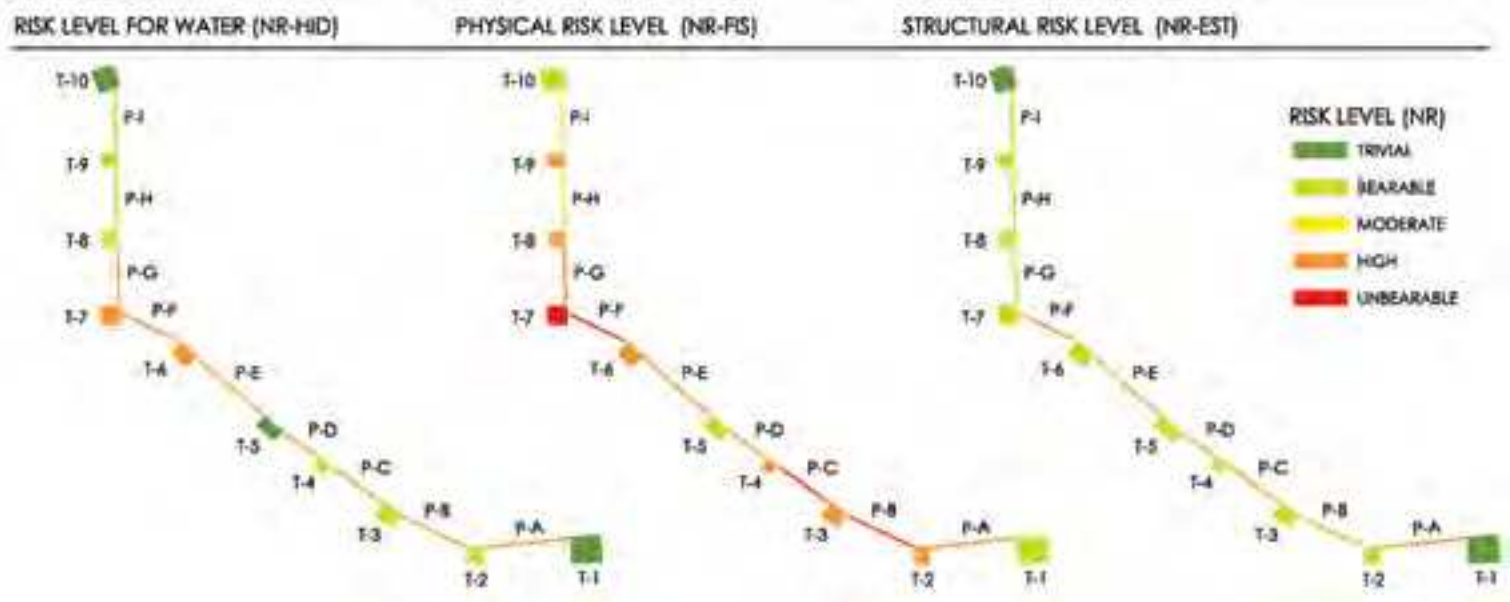
Fig.2 Distribution of the NR for the analyzed wall sections (T1 through T10) (credits: J. Canivell, 2011)

analyzed. Red represents an accumulation of high levels for risk factors and, therefore, high risk of occurrence and development of pathological processes, producing serious consequences to the asset or its users. The diagrams show how the highest vulnerability corresponds to NR-FIS (erosion, de-cohesion, mass loss), and especially in the fabric and intermittent towers from Towers 1 to 7, which also corresponds to the first phase of intervention (Table 1). In these most vulnerable sections, corrective measures are urgently needed to repair damage, as well as preventive measures to mitigate risks and to ensure greater durability.

The current situation of the Niebla wall, in sectors that have had no interventions in the last decade and also considering the sectors under study as a benchmark, presents vulnerability to erosion. Sections B, C and F are the most affected and sensitive, and also have high NR. These sections coincide with the first phase of restoration of Guarner González (1987). In later stages of the work, the technique and the materials used were improved, evidenced by better vulnerability conditions (sections between Towers 7 and 10). The work of Manzano (1974-75) in Tower 7 has demonstrated poor performance and shows a high NR. The poor condition and vulnerability of some elements is based in a series of associated damages: short mass composition and poor compaction of the restored rammed earth, loss of adhesion

This assessment methodology provides an easy and useful tool to prioritize repair actions on a set of components, assigning different levels of intervention (NI) for each NR. For high NR, more urgent preventive measures and stronger corrective measures will be required, thus reducing vulnerability. Also, in the case of high NC, maintenance plans should be implemented or revised.

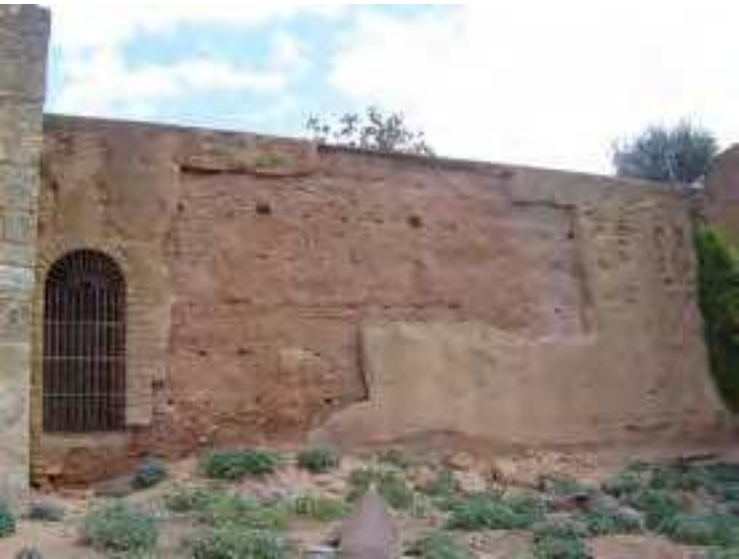
Fig.3 Damage in earthen the fabric of the wall between Towers 6 and 7 in 2009 (credits: A. González, 2009)

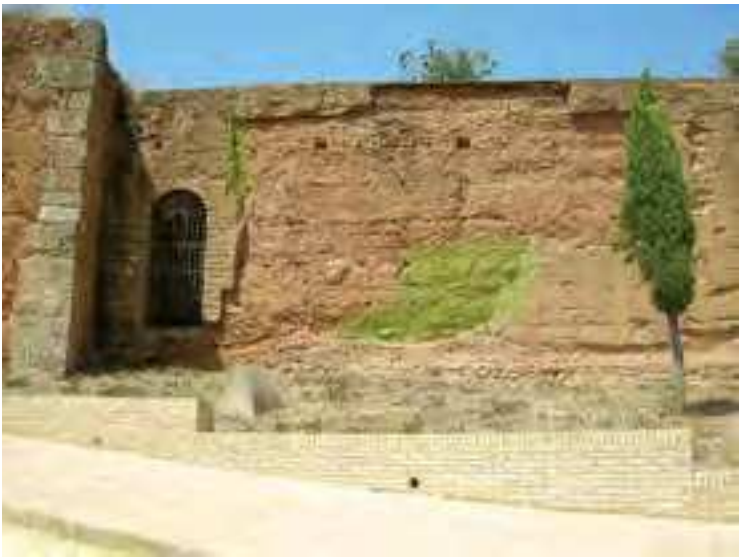
Fig.4 Damage in earthen the fabric of the wall between Towers 6 and 7 in 2011 (credits: J. Canivell, 2011)
