EARTH AS A STABILIZATION AND CONSOLIDATION ELEMENT FOR BUILT-HERITAGE FOUNDATIONS: TWO CASE STUDIES IN BRAZIL

Silvia Puccioni

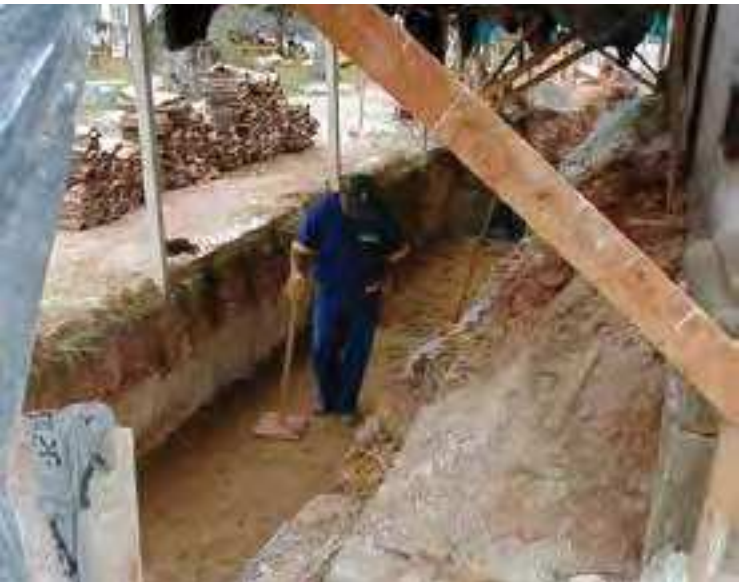
As the diagnosis suggested, the main cause of the damage to the structure was related to the low capacity of the surface soil to support the foundation, especially in the area at the front of the monument, which led to another intervention strategy. Whereas the foundation’s resistance capacity was unproblematic, the ground around it was not. Therefore, the hypothesis arose of directing the intervention to the lateral soil supporting the foundation and not the foundation itself. The substitution of the lateral soil bordering the two sides of the foundation, by another soil with adequate physical and mechanical characteristics to perform the geotechnical functions necessary to promote stability of the monument was suggested; thereby increasing the resistance to breakdown through shear forces of the foundation soil. This would also reduce to acceptable levels the slow densification process of the foundation soil, while preventing degradation by short- and long-term phenomena.

Studies for the detailing and specification of the rammed earth veneer began with geotechnical studies performed in the laboratory, using samples of natural soil collected at two points at the level of settlement of the foundations in the region of the towers, in order to verify geotechnical characteristics, including permeability. It was proposed to stabilize the rammed earth veneer with the addition of a small amount of cement to reduce its permeability. Laboratory tests showed that the mixture of natural earth with cement resulted in a material with ideal permeability and resistance characteristics to reintroduce the mass of earth laterally bordering the foundation, indicating the success of the working hypothesis. This solution was linked

Fig.2 Rammed-earth veneer to protect the foundations of the Igreja Matriz De Santo Antonio (credits: Silvia Puccioni, 2000)

The developed project consisted of protecting the area of lateral influence of the foundation by associating resistant and low-permeability veneer of rammed earth with an underground drainage system peripheral to the outer area of the monument. The drainage system was intended to eliminate or reduce the variation of groundwater levels, and incorporated surface drainage, which would allow a rapid evacuation of the accumulated water from the grass and paved areas, including the existing street at the back of the church.

The implementation of a rammed-earth veneer to protect the foundations was divided into three parts, starting from the part of the right tower, followed by the part of the left tower, and finally the central part of the *façade* (Puccioni, 1988). This sequence aimed to relegate to the last stage of intervention to the central section, the most sensitive area, being the veneer of *Aleijadinho*. Thus, the risk of structural movements was avoided during the accomplishment of the work on the *façade*, as the lateral sections were already stabilized.

The second stage involved the excavation of the two sides of the foundation in alternating trenches of 1.00 m length and 1.00 m width, in order to install the rammed earth veneer adjacent to the foundation. The excavation was carried out to the level of settlement of the foundation, and the removed material placed next to the excavation. In a third stage, the voids, gaps and failures of the foundation blocks were in-filled, using variably graduated stones.

Afterwards, the ‘shearing tooth’ was prepared, consisting of the removal and subsequent reinstallation of larger stones, greater than the interface of the block and rammed earth veneer.

The next phase comprised the immediate rebuilding with rammed earth, compacted in layers up to the height of the original floor. Finally, the rebuilding of external and internal floors, removed in the first stage, was completed.

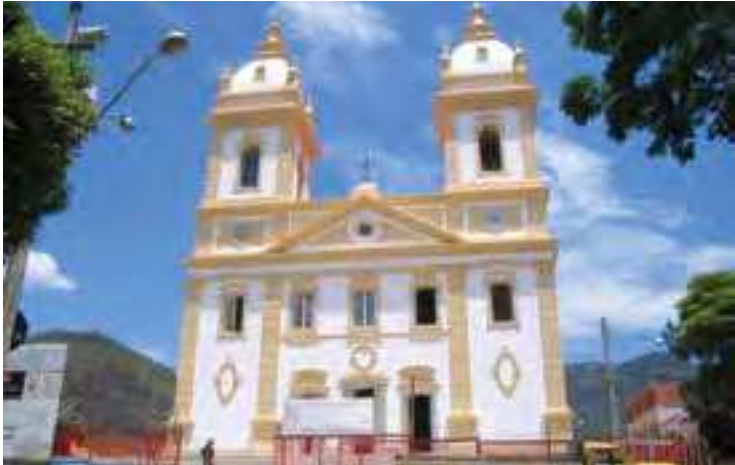
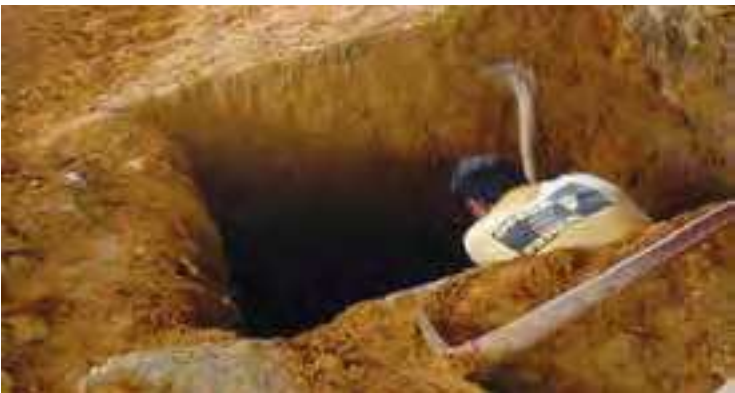
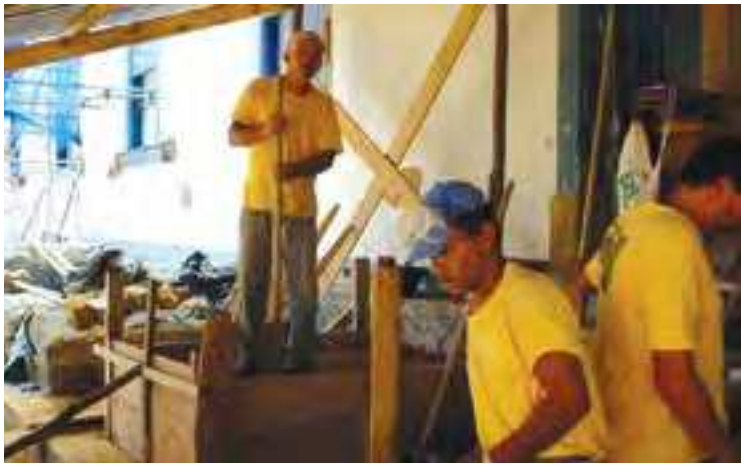
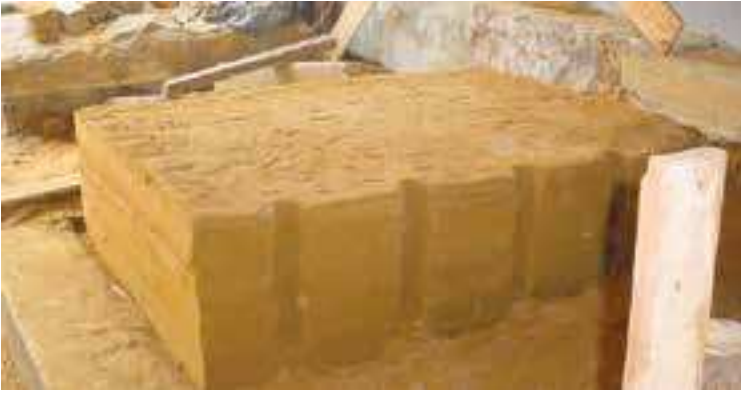
In this case, the issue involved stabilizing the area of the foundation of the towers that were in precarious condition. The instability of the towers, which had already fallen, was related to the precarious condition of the soil at the foundations, which included disaggregation and high humidity. Another cause was the mismatching base due to the extraction of soil in the second decade of the 20th century, when it was undermined by the construction of a square on the adjacent plot. The restoration of the support of the foundation through the reconstruction of a section was implemented on the sides and fronts of the towers in the adjacent plot, by installing a rammed-earth veneer, and thus restoring the original ground level. With this resolution it was possible to re-stabilize the church without further intervention in the square.

Fig.3 Cathedral of Nossa Senhora da Glória in Valença, Rio de Janeiro, Brazil. Rammed-earth veneer at the bottom of the *façade* is observable (credits: Silvia Puccioni, 2000)

The recovery of the foundations of the churches was performed using the following steps: removal of the floor, digging in alternating trenches with variable widths; in-filling voids, gaps and failures along the foundation blocks; re-pointing of the foundation masonry; linking of elements between the earthen veneer and the existing foundation. Immediately afterwards, infill with cyclopean rammed earth was accomplished. Finally, the original floors removed in the first stage were rebuilt. A system of surface and underground drainage was built as well, in order to maintain a constant level of subsoil moisture.
