AFTER THE FLOOD: DEVASTATION OF THE TRADITIONAL EARTHEN ARCHITECTURAL LANDSCAPE IN THE HADHRAMAUT VALLEY OF YEMEN; CAN MUDBRICK BUILDINGS BE MADE MORE RESISTANT TO CLIMATE CHANGE?

Pamela Jerome, AIA, LEED AP

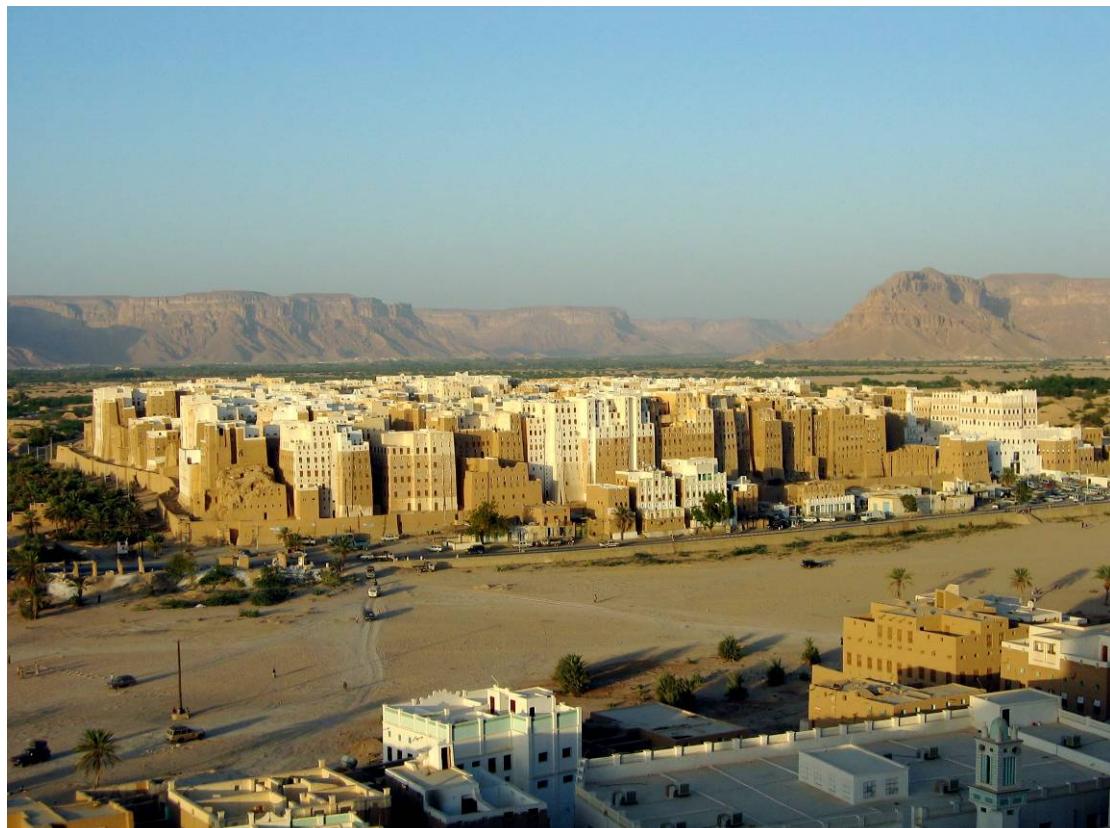
Fig. 1 – The walled city Shibam was inscribed on the World Heritage list in 1982. Although mentioned in the Bible, the town, in its present configuration with ten-story mudbrick tower houses, dates to 1533. (credits: Pamela Jerome, 2006)

The Hadhramaut Valley is well known for its sophisticated mudbrick construction of tower houses. Clustered on the escarpments of the 300-meter high limestone and sandstone cliffs, this building typology developed to fulfill defensive requirements from tribal warfare in the past, the desire to keep the fertile valley floor free for cultivation, and the need to protect against occasional flash floods (Jerome et al., 1999, p. 40). The walled city of Shibam, the World Heritage Site in the region often referred to as the Manhattan of the Hadhramaut, exemplifies the typology of tower houses although not along the escarpment – it rises above the valley floor on an ancient tell (Fig. 1).

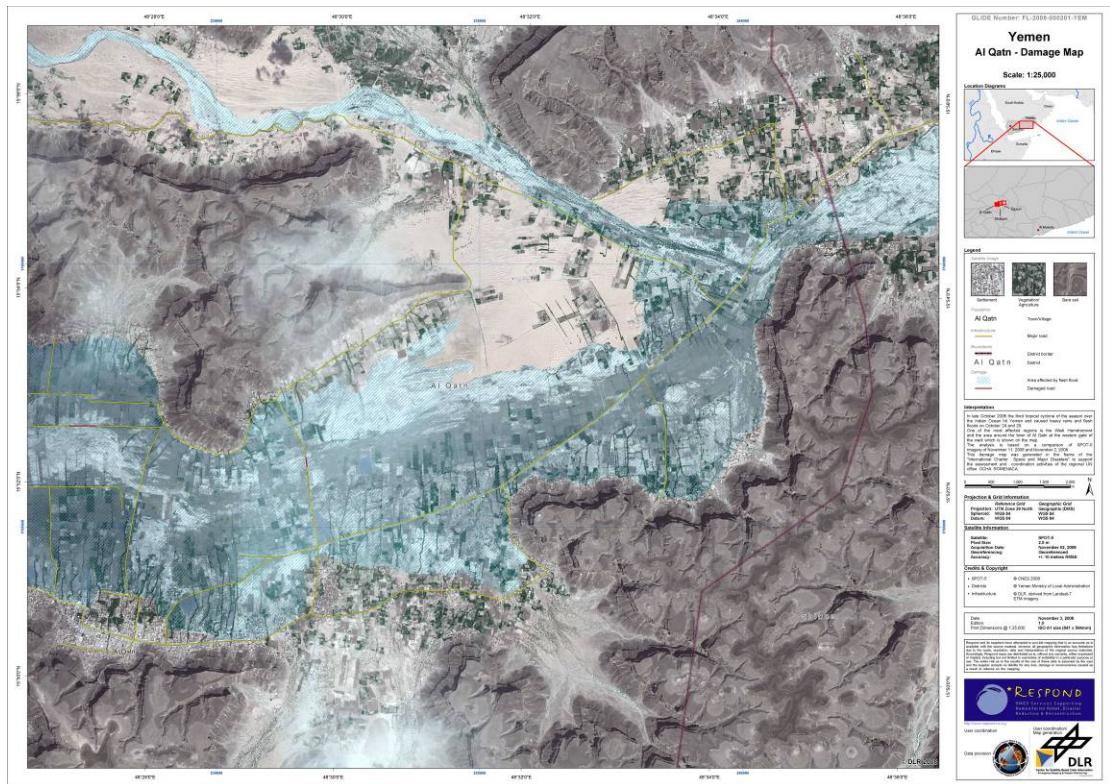
Fig. 2 – Satellite image of the Wadi Hadhramaut in the vicinity of al-Qatn, where over 700 buildings were lost. (credits: DLR, 2008)

the case during the 23-24 October 2008 flash flood; however, there are known areas of the flood plain to be avoided, and despite this, construction occurred (Fig. 2).

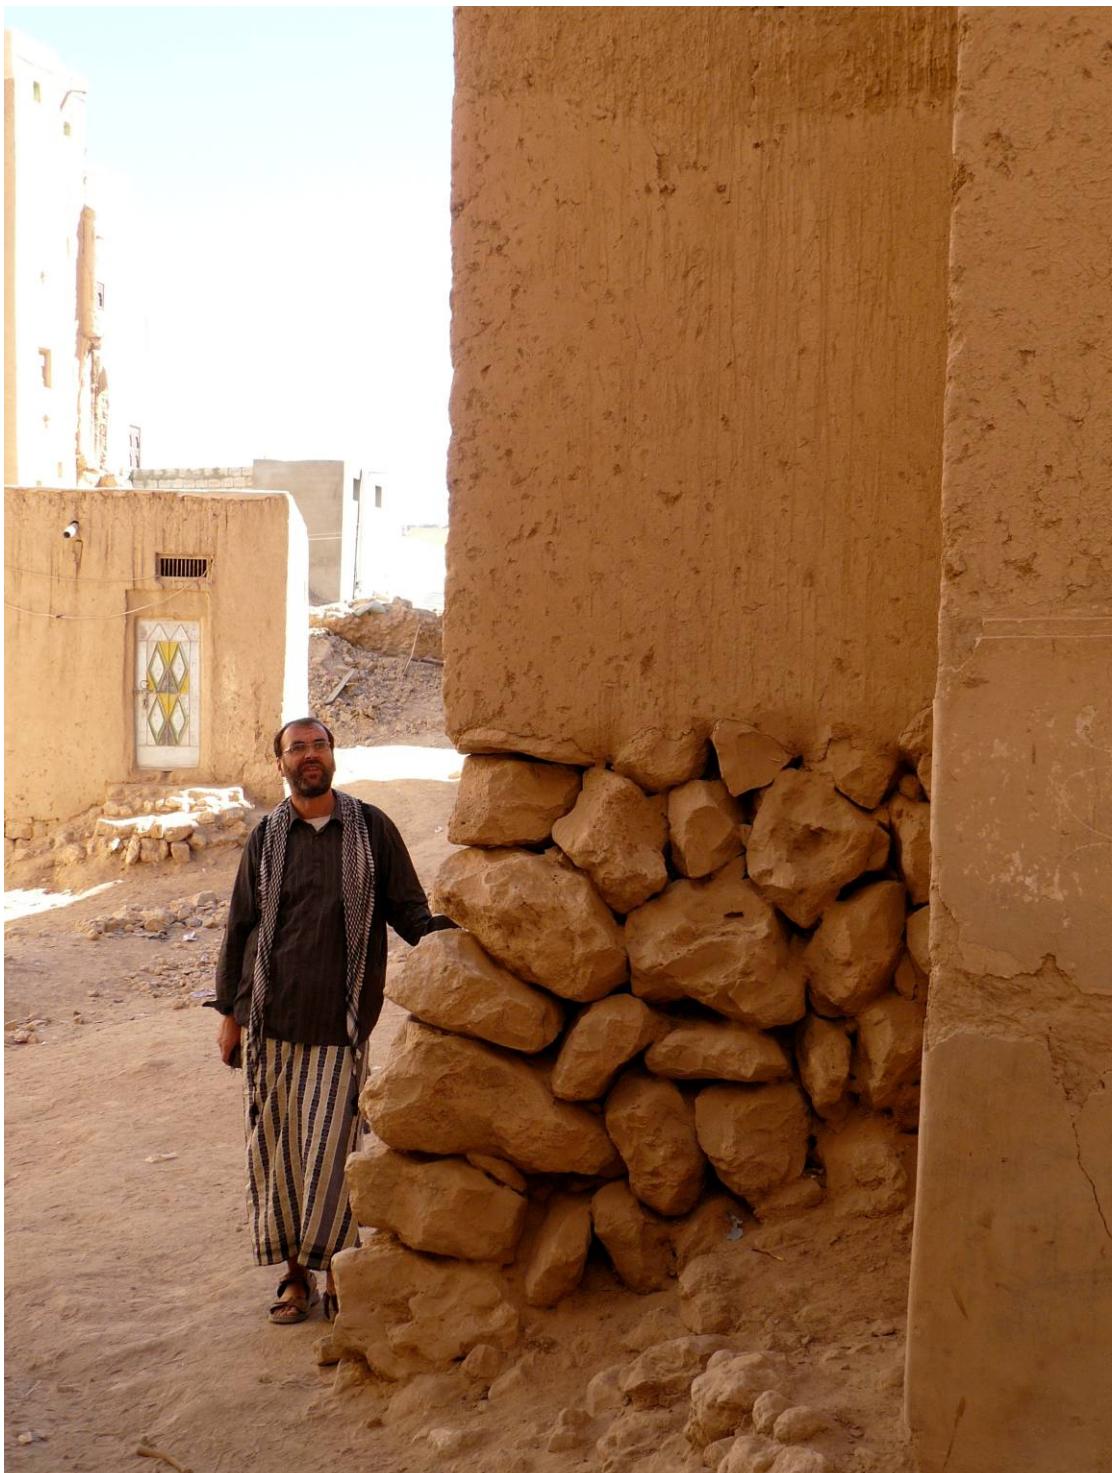
Fig. 3 – Dry rubble-stone foundations in the Wadi Do'an can be over 1.50 m in height, and in this case, closer to 1.80 m. Pictured here is a tower house in the notable village of Budha located in the right branch of the Wadi Do'an. (credits: Pamela Jerome, 2008)

Many of the damaged newer houses had inadequate or no foundations. Foundations, traditionally of stone, require 2 m below grade as well as about 1 m of exposed stonework above grade (Jerome et al., 1999, p. 42). Judging from examples in Wadi Do'an, where the valley is narrower and the escarpments steeper, the above-grade height is over 1.50 meter (Fig. 3). Steep narrow streets also act as spillways during flash floods, with dry-stonework serving both to retain the hillside and to break the force of the cascading water.

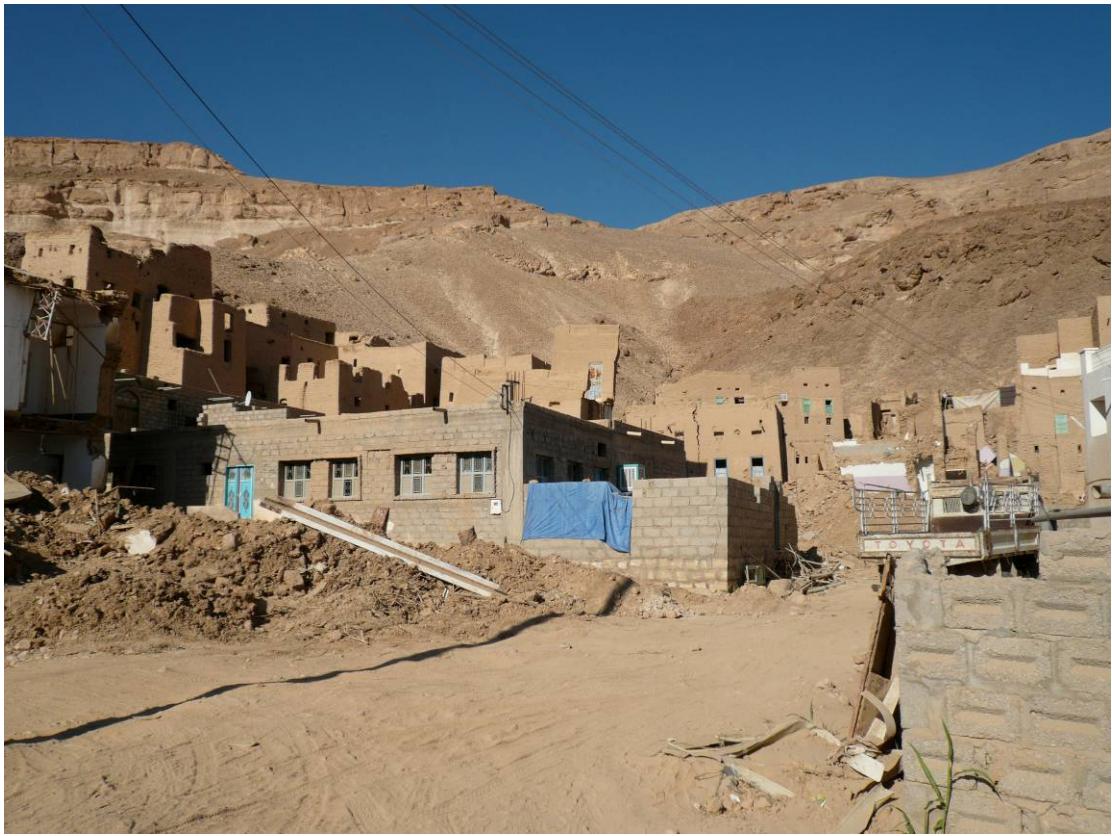
Many of the damaged mud buildings were adjacent to concrete construction (Fig. 4). The concrete construction acted as barricades, and so the floodwaters found a new path. The turbulence created by concrete in the path of floodwaters and its rebounding effect pushed the flood towards more vulnerable buildings.

Fig. 4 – Recent incursions of concrete construction into traditional villages caused damage to surrounding mudbrick structures during the flood through turbulence and rebound effect. This example is in al-Jihad to the east of Tarim. (credits: Pamela Jerome, 2008)

If concrete foundations are going to be used, then the concrete needs to be isolated from the mud foundation fill and the mudbrick superstructure. This can be accomplished by application of a bitumen coating or installation of a plastic sheet. These foundations could also be lime plastered for aesthetics, thus concealing the fact that they are concrete.

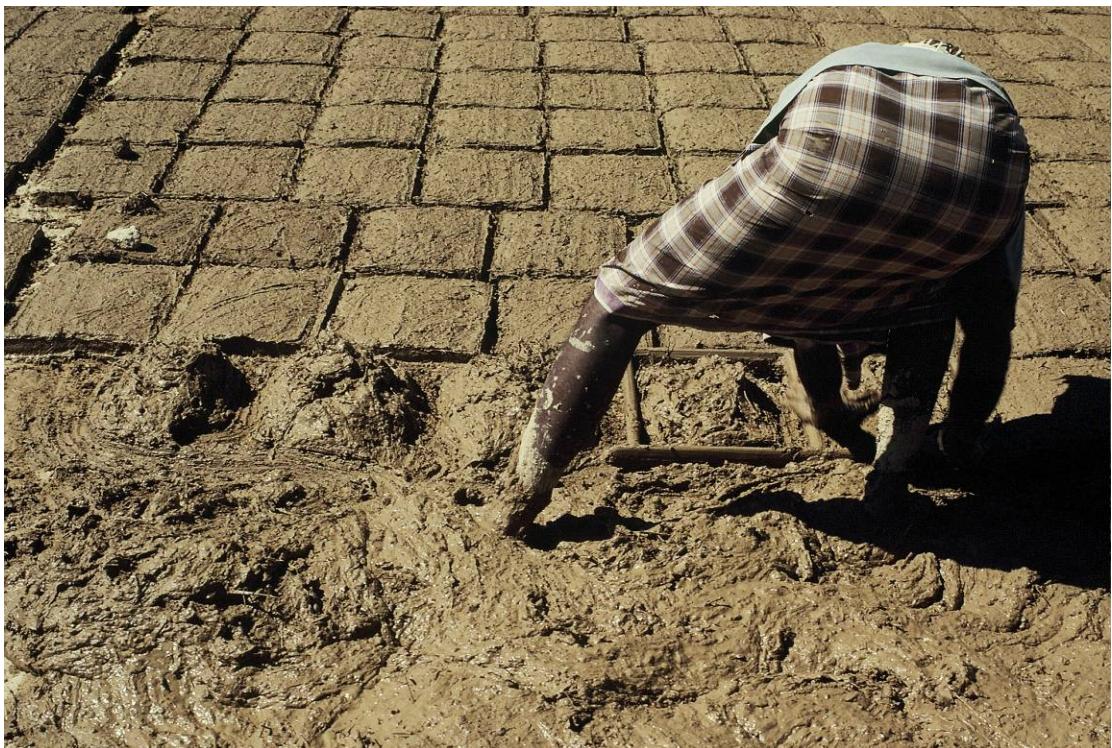
Water is also an important ingredient, but how much water is too much? For instance, too much water weakens cement, and cement-to-water ratios are closely controlled for this reason. There appears to be a similar situation with clay, the “cementing” component of soil. Reviewing past documentation from a commercial mudbrick yard in Seyoun, the mud mix is the consistency of pea soup (Fig. 5). The result is mudbricks that are brittle and break with little exertion from the hand. By comparison, in Wadi Do'an, the mud mix is stiffer and the bricks thicker and stronger (Fig. 6).

Fig. 5 – The quality of mudbricks is affected by the amount of water and straw, as well as the type of soil. In this commercial yard in Seyoun, brittle mudbricks result from a pea-soup consistency mud mix. (credits: Pamela Jerome, 1997)

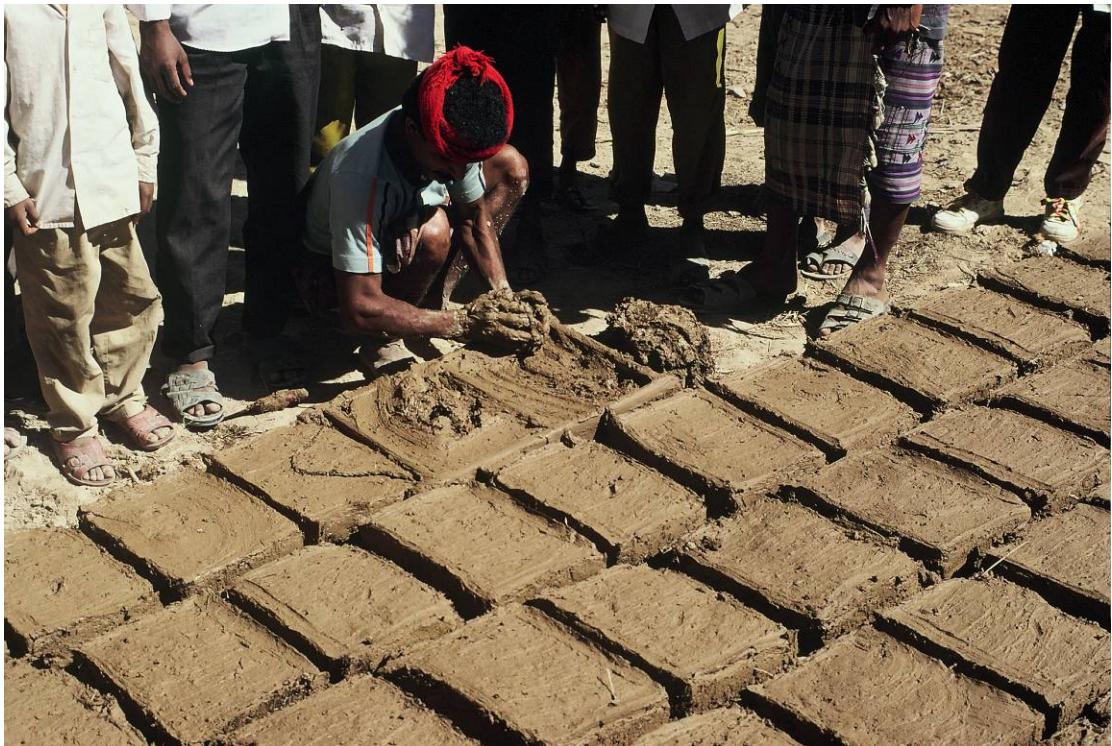
Fig. 6 – In Khoreibah, deep within Wadi Do'an, the mix for mudbricks is stiffer resulting in better quality. (credits: Pamela Jerome, 1997)
