EARTHEN-BUILDING CULTURES AND SEISMIC HAZARD: CHILEAN TRADITIONAL ARCHITECTURE

Natalia Jorquera Silva

Theme 1: Latin-American Architecture at Risk: Earthquakes, Rain and Flood Damage  
Keywords: Building culture, earthen-architecture, seismic hazard

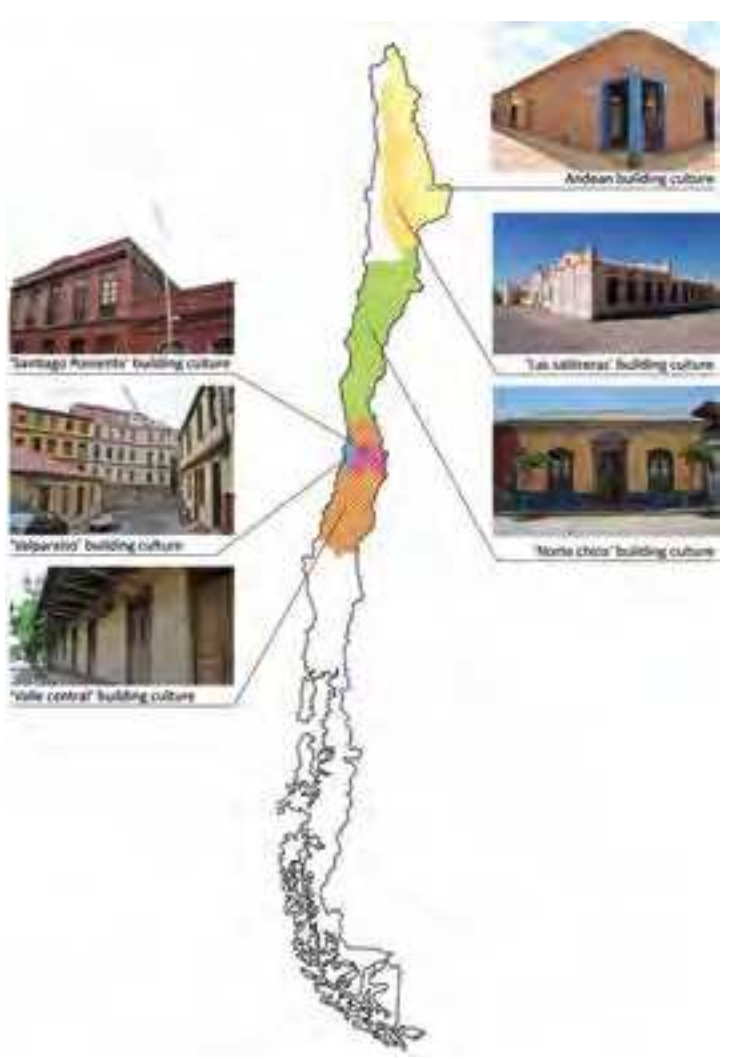
Fig.2 Map of earthen building cultures in Chilean territory (credits: Natalia Jorquera, 2012)

Six building cultures were identified, each with a distinct territorial extension from which a name was assigned. Established for each were: the architectural and technological typologies that form it, the period of historical development, the conservation status (some are “lively” cultures, others instead are in the process of decay and almost vanishing), and the threats (environmental and socio-cultural) within which the seismic risk is the common denominator. Thus, a fundamental aspect within the classification was the identification of earthquake-retrofitting strategies of the building culture. Ordered from north to south, these are:

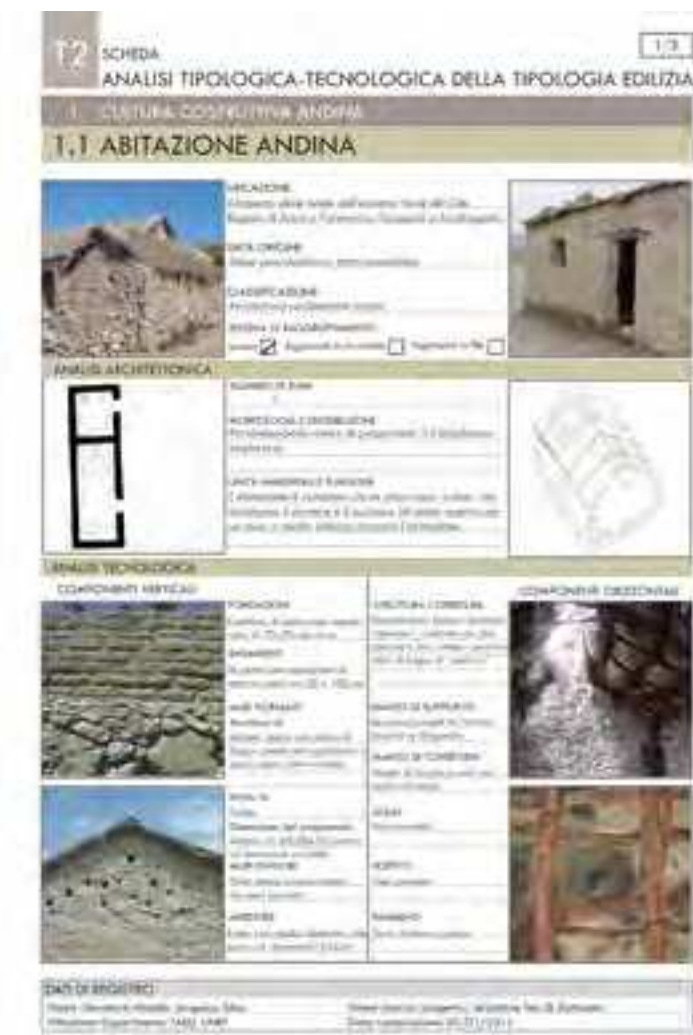
Fig.4 Example of the constructive-structural analysis factsheet of the Andean-type housing (credits: Natalia Jorquera, 2012)

The great vulnerability of all types belonging to the Andean culture is the “non-monolithic” behavior of the whole, due to the poor quality of the material used for adobe and associated mortar; errors during the execution of the work (as in the irregularity of the building, and the excessive thickness of the mortar); and construction errors, such as lack of interlocking between the party walls, and the absence of ties (between walls, and between walls and roof), which gives rise to an “accumulation of elements” rather than a structural unit. To this, add the excessive weight of the layer of mud and straw, used as insulated roofing, which generates an overload of around 300 kg/m<sup>3</sup>, where the structure is weakest. The load is incorrectly transmitted to the walls, due to the misconfiguration of the trusses, which are composed of wood of little structural strength, small dimensions, and excessive horizontal spans that fails to create a triangular shape. Nevertheless, it is still a structure that generates thrust on the walls, which already have problems resisting their own weight. Despite these characteristics, the housing is not highly impacted by the seismic thrust, due to its

small size, simplistic and symmetrical geometry.  
C) Evaluation of seismic hazard of the territory to which the culture belongs (4):
