LA JOYA EARTHEN PYRAMID AFTER HURRICANE KARL, SEPTEMBER 2010, ON THE GULF COAST OF MEXICO

Annick Daneels, Luis Fernando Guerrero

Theme 1: Latin-American Earthen Architecture at Risk: Earthquakes, Rain and Flood Damage
Keywords: Archaeology, Veracruz, Mexico

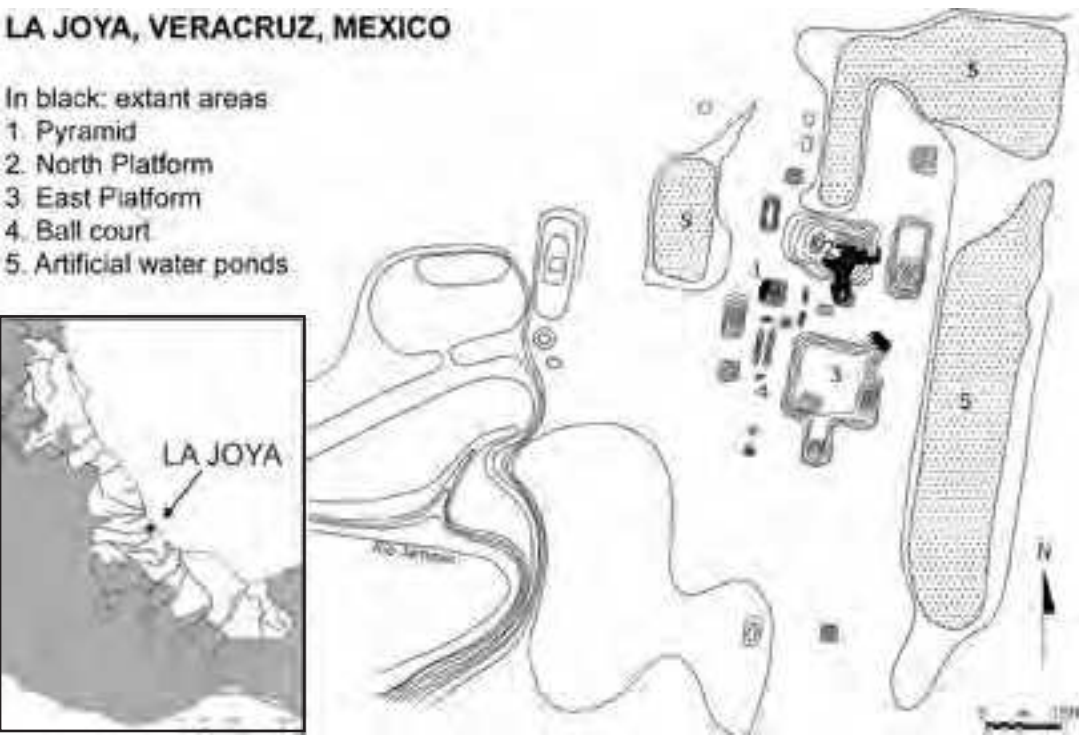
Fig.2 Map of La Joya, with central compound surrounded by a system of ponds. Inset: location of site within the State of Veracruz (credits: Annick Daneels)

La Joya is exceptional in this respect, as due to extensive damage by brick makers only 5% of three of the mounds remain (Fig. 2, extant portions shown in black), exposing large profiles of superimposed buildings and allowing the definition of the building sequence and the analysis of construction techniques. The oldest building is the North Platform, apparently starting as a palatial complex enclosed by a perimeter wall, radiocarbon-dated to 400-100 BCE (Daneels, 2008a, 2011). An enclosed plaza complex framed by the Pyramid and the North and East Platforms, including a first version of the water-pond enclosure, arises by 200 CE, in the early part of what is called the Classic period in Mesoamerica. The complex had several renovations, the last one about 800/900 CE, with the site apparently abandoned by 1000 CE. The intervention at the site was done originally as a rescue operation, with no restoration contemplated. But the discovery in May 2008 of the pyramid's substructure led to the decision to attempt the preservation of the extant remains of its west façade.

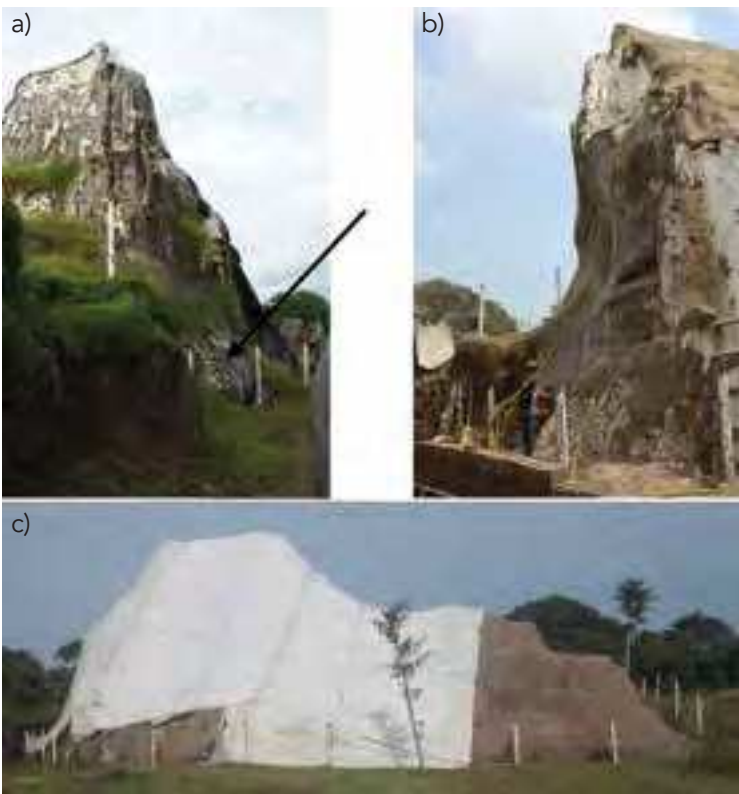
Fig.4 La Joya Pyramid in spring 2010: a. arrow indicates collapse of north retaining wall due to weeds, b. geotextile applied directly to north profile, c. west façade protected by tarpaulins, whereas for the southern sector (on the right) with the new sacrificial layer with vinyl polymer (credits: Annick Daneels, from project authorized by the Archaeology Council of Mexico's National Institute of Anthropology and History)

rainwater into the sand fill and weakened the wall. In spring 2010, the debris was cleared and geotextile applied directly to the fill profile. A new experimental layer of increased resistance was developed and tested in the Restoration Laboratory of the Institute of Anthropological Research, and applied only on the southern sector of the façade. It consists of a first thin layer of sand/loam mix in equal proportion, then a second 1.5 cm thick layer of the same sand/loam mix with 1,5% finely chopped Pangola grass (1), 0.8% of vinyl polymer (Wacker VINNAPAS 5044N), and 0.3% of hydrofugant (Wacker SILRES BS Powder D). The cracks that appear in the layer are afterwards sealed with a sand/loam mix with a 5% addition of the same polymer, to insure compatibility and give elasticity to the cover.

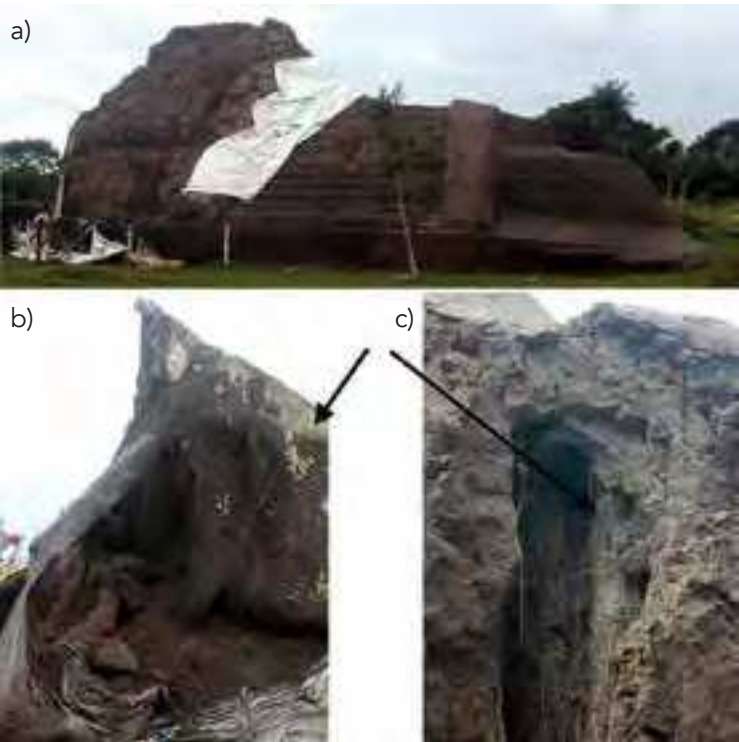
The 180-km/h winds from Karl hit the pyramid from the south, a direction opposed to the local dominant winter winds. This lessened the impact on the structure, as the wind rode over the wedge-shaped vestige that increases in height and width from south to north. Nevertheless, the tarpaulins were torn off, exposing the surface to the 250 mm of rain. Affecting only a very small part of the façade's edge, part of the original fill of the north profile collapsed, stretching the geotextile to a breaking point. Unknown to us, below

the tarpaulins, weeds had started to grow again along the northern edge of the façade.

When removing the geotextile, it was possible to observe the presence of more than 1-m deep weed roots in the fracture zones, penetrating the original compacted-earth fill of the building and the modern sandy fill placed in 2009 as part of the raw brick retaining-wall system. The weeds did not grow on the façade itself, but on its northern edge, formerly exposed, where before preservation attempts, an invasion of a sturdy weed existed, identified as *Cyperus rotundus* L. of the Cyperaceae family. This weed has long rhizomes forming chains of bulbous tubers that developed below the geotextile, and cannot therefore be removed manually without damaging the textile, nor killed with standard glyphosate weed killers. It was first used FAENA forte (Monsanto) in 2009, then Finale Pro 15 (Bayer) in small experimental patches in 2010, at the recommendation of biologist Pablo Torres Soria, consulting specialist of the National Institute of Anthropology and History in Mexico in matters of site preservation. These applications were suspended in view of their inefficacy and the high toxicity of the products. This weed even broke through the polymer-consolidated sacrificial layer, showing that being cut off from sunlight does not affect its vitality. The presence of the roots suggests a repetition of the 2009 scenario: the weed catches the rain and allows it to penetrate along its roots beyond the geotextile, 1- to 2-m deep into

Fig.6 La Joya Pyramid in September 2010, after hurricane Karl: a. west façade with torn tarpaulins, southern sector (on the right) with polymer layer in good condition, b. collapse of north profile fill, arrows indicating weeds and roots, c. detail of weed roots in old crevices, originally filled with sand (credits: Annick Daneels, from project authorized by the Archaeology Council of Mexico’s National Institute of Anthropology and History)

the sandy fill of the building itself. The ensuing differential humidity weakens the fill stratum that does not have the clay content and compaction of the capping layer of the façade. The steep incline of the north profile led to an almost vertical slide, in line with the weed-root penetration.

What has become evident is the necessity of avoiding sandy fills when building the retaining walls, as they allow drainage to occur too rapidly and provoke differential humidity that weakens the compaction of the fill. Also, it is very important to continuously monitor weed growth, especially those that have deep root systems that penetrate beneath the geotextile, curtailing its protective action. A strategy to control weed growth needs to be developed, as the usual weed killers have proven ineffective.

In 2011, the pyramid was completely covered with the experimental vinyl-polymer layer on top of the geotextile, after building a stronger retaining wall around the north profile, filled in with layers of loam stabilized with lime, based on the experiments made at the Materials Laboratory of the UAM-Xochimilco (Guerrero and Roux, 2010: 93-94). These are provisional preservation measures while the laboratory analyses proceed both on pre-Columbian samples of facings, in an effort to determine the original organic agglutinant, and on other experimental sacrificial layers using vernacular techniques extant in tropical-rainforest environments in Central America, as well as other, modern components. Bi-monthly monitoring will continue at least until the end of the year, for the duration of the actual project.
