DISASTER-RISK MANAGEMENT OF CARAL WORLD HERITAGE SITE, PERU

Rohit Jigyasu, Julio Vargas-Neumann

Theme 1: Latin-American Earthen Architecture at Risk: Earthquakes, Rain and Flood Damage

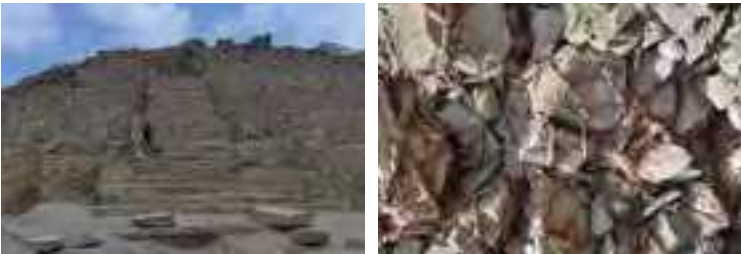
Fig.1 Staggered Pyramid “La Galería”, in Caral, from 3,000 BC. The complex is built in stone masonry, earth mortar and wattle-and-daub (credits: Julio Vargas, 2011)

Fig.2 Remnants of shicras used for bagging stones for stable pyramids cores (credits: Julio Vargas, 2011)

20 strong earthquakes, according to this area’s statistics of seismic recurrence (Shady et al., 2009). The people from this civilization were aware of the damage caused by recurring earthquakes, which destroyed their walls, made out of stone and earth mortar, and caused the collapse of their pyramids’ platforms. Consequently, they attempted to implement seismic-resistant methods to their construction techniques. In order to build platforms at different heights, they realized that the core material should not cause any pressure on the external vertical borders or façades, also built with stonework joined with earth mortar. The main goal was to have a very stable core to resist earthquakes, while permitting some damage in the reparable façades.

The builders discovered that angular stones were more rugged, so the core material had a larger angle of repose that produced less horizontal loads on the borders and façades. Moreover, the angular stones without earth fill led to a larger percentage of empty spaces, thereby creating walls with lower specific gravity that produced even less horizontal loads. However, it was necessary to eliminate horizontal loads, and then the core had to be stable and resistant to horizontal seismic movement.

The builders then discovered that by “bagging” the stones with adequate tensile-resistant material (vegetal fibers), they could control stone displacement and also prevent the bags from pushing each other, thereby creating a layered and stable core that did not produce any stress on the façade walls. These bags, shicras, were made with vegetable fibers from the highlands, and contributed to the creation of a seismic-resistant technique that increased the buildings’ strength for a very long period, longer than their own average service life, although time, open air and ultraviolet radiation eventually decomposed the bags’ organic material. These were precursors of the modern day gabions and thus were earthquake-engineering pioneers.

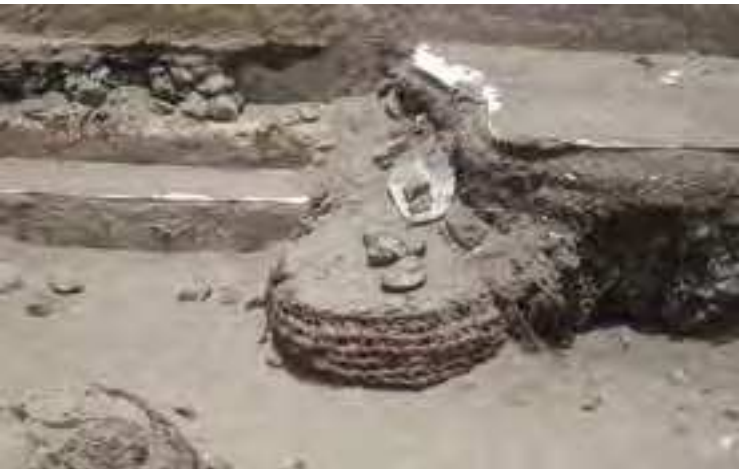
Fig.3 Remnants of shicras used for bagging stones for stable pyramid cores (credits: Julio Vargas, 2011)
Fig.4 Quincha (wattle-and-daub) is an earthquake-resistant composite technology (credits: Julio Vargas, 2011)

The builders also used *quincha* (wattle-and-daub), a composite technology using wood, cane, vegetal fibers and earth, coated with a plaster made of mud and straw.

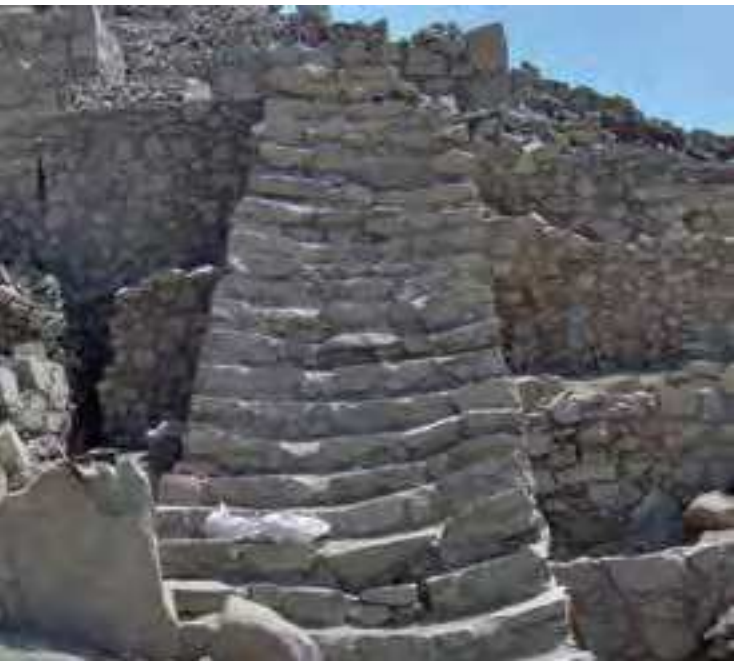
Fig.5 Unstable stairs requiring the renewal of shicras (credits: Julio Vargas, 2011)

However, damaged internal bagging with shicras must be renewed in the core of all Caral's pyramids (Vargas, Iwaki, and Rubiños, 2011) because the level of earthquake risk for Caral is so high. The scenarios are ranked based on probability, and consequences on property, values and qualifiers. The façades have a higher probability of damage than the pyramids' cores, as was clearly intended by the original builders. However façade walls are not well connected with the stable core for reasons explained before in this paper. Reinforcement to connect these two elements is surely too intrusive and unacceptable.
