CHALLENGES IN PRESERVING THE WORLD HERITAGE EARTHEN SITE OF CHAN CHAN, IN PERU

Mariana Correia

Theme 2: World Heritage Earthen-Architectural Sites, Natural Disasters and Climate Change

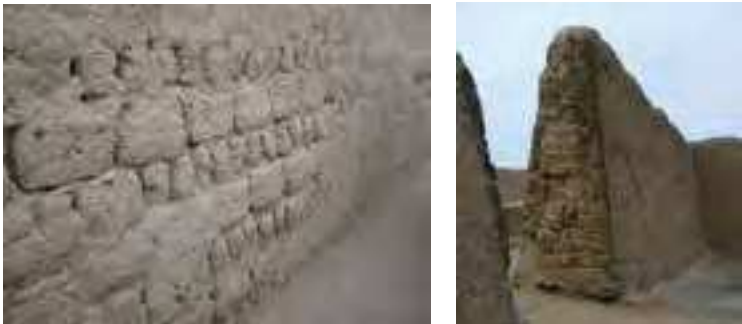
Fig.2 Different dimensions of adobes at Tschudi palace (credits: Mariana Correia, 2005)

Fig.3 Section of partially destroyed citadel wall (credits: Mariana Correia, 2005)

A high degree of control of the construction material and the building method can certainly be discerned related to adobe use in Chan Chan, with more than 17 different shapes of adobes identified at least for the complex walls (Campana, 2000, p. 117). For instance, a specific type of adobe with a truncated-pyramidal shape was applied for the citadels’ surrounding walls. These walls had major relevance at the time and were built for defensive purposes. In the case of Tschudi Palace, the citadel wall has a height of 12 m and is 1,500-m long (Pinillos, 1995, p. 28). To ensure strong and thick earthen walls, the citadel’s surrounding walls were built wider at their base and narrower at the top. With the increase of height, the wall thickness would decrease, as would the size of adobes. In this way, deterioration was avoided, due to “humidity and the salinity of the earth, and ensured that it [would be] earthquake-resistant” (Pinillos, 1995, p. 15).

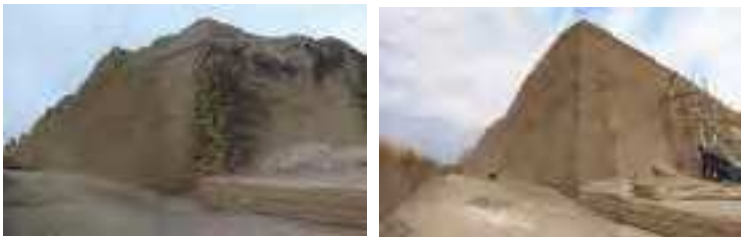
Fig.4 Before restoration: Tschudi citadel surrounding wall (credits: Mariana Correia, 2005)

Fig.5 Following restoration: Tschudi citadel surrounding wall (credits: Luis Guerrero, 2007)

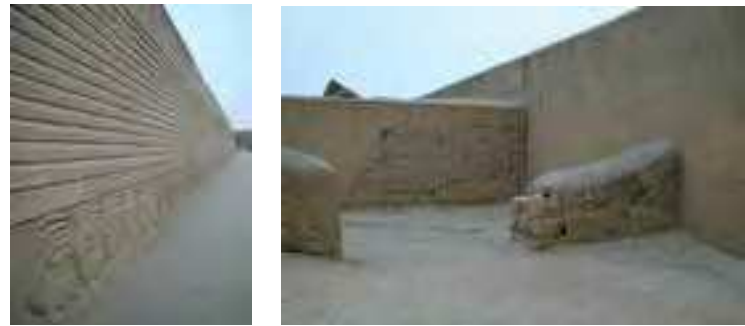
Fig.6 Grand Ceremonial Plaza with reconstructed walls during the 1960s, Tschudi palace, Chan Chan (credits: Mariana Correia, 2005)

Fig.7 The reconstruction of the surrounding wall done during the 1960s is identified on the exterior of Grand Ceremonial Plaza, Tschudi palace, Chan Chan (credits: Mariana Correia, 2005)

Chan Chan has had several conservation interventions in the last 50 years. Castellanos considers the existence of two conservation phases (2000, p. 71). The first phase was between 1964 and 1969 and relates to the Tschudi Palace intervention with a “type of highly criticized pastiche ... to satisfy the demands of mass tourism” (World Heritage, 2007, p. 8). Castellanos states that this was “largely oriented toward reconstruction for formal presentation” (2000, p. 71). The reconstruction of walls and frieze decorations can be observed in the Grand Ceremonial Plaza at the Tschudi Palace. Morales Gamarra supports the

criticism about the arbitrary reconstruction undertaken in Chan Chan (2007, p. 264). After 1974, “a stronger emphasis was placed on ... stabilization of structures, through the application of sacrificial renders and capping ...” (Castellanos, 2000, p. 71-72). As previously mentioned, capping with soil cement was addressed on some of Chan Chan’s earthen friezes (Alva Balderrama and Chiari, 1995, p. 105). Morales Gamarra directed criticism to some UNESCO experts who applied a stabilized mortar of soil-sand-cement as capping (1983, p. 112). As an alternative solution, the use of lime-soil was first proposed for capping and for the stabilization of the friezes, and the use of acrylic emulsion, as well as other chemical substances, such as Polyvinyl Acetate. Morales Gamarra stated that results were not satisfactory as there was recurrent exfoliation due to the high humidity (1983, p. 113).

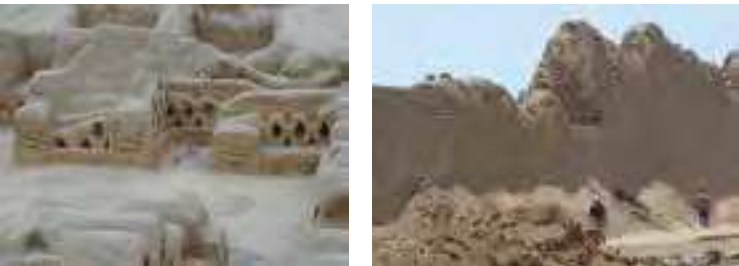
Fig.8 A sacrifice layer of gravel is used to protect the top of the walls. Audiences sector, Tschudi palace (credits: Mariana Correia, 2005)  
Fig.9 Reconstruction of the surrounding wall in Velarde palace, Chan Chan (credits: Luis Guerrero, 2007)
