RAMMED-EARTH ARCHITECTURAL HERITAGE IN HAVANA, CUBA: PRESENT AND PERSPECTIVES

Francisco Tomas Casal Iglesias

Theme 2: World Heritage Earthen-Architectural Sites: Natural Disasters and Climate Change

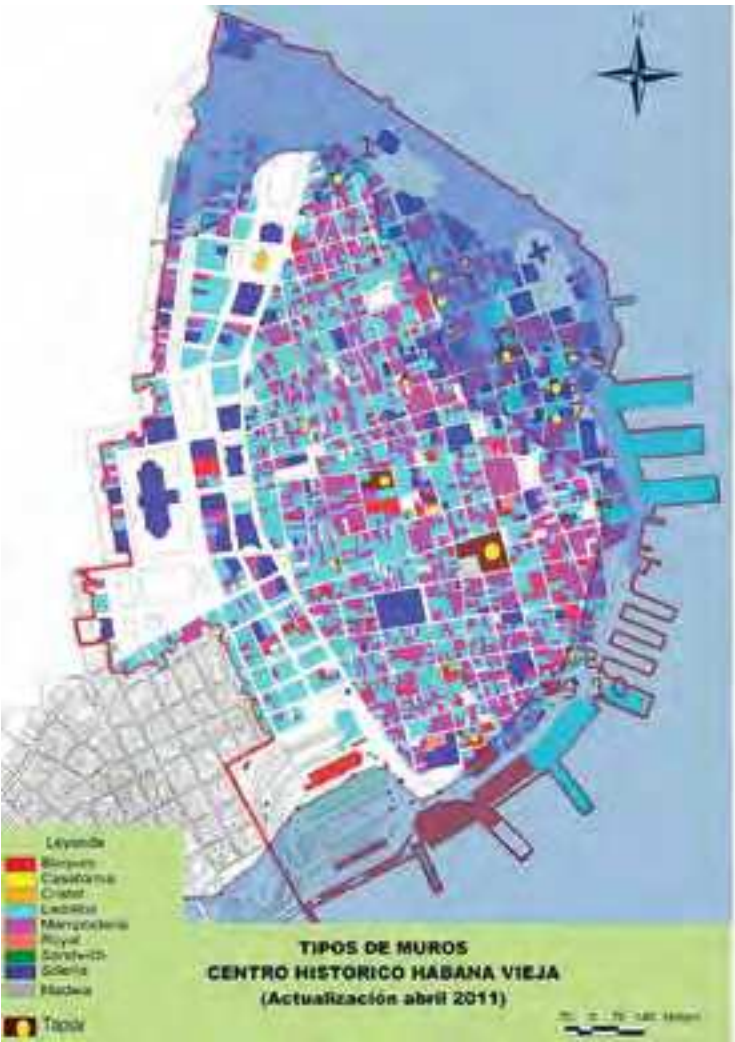
Fig.2 Inventory of wall types, and primary and secondary flooded areas in Old Havana; yellow circles reveal rammed-earth construction (credits: Rodriguez, 2011 - Plan Maestro de la oficina del Historiador de la Ciudad de la Habana, Dirección de Planificación Física Ciudad Habana y CITMA Ciudad Habana, 2006-2011)

A possible scenario of overlapping floods of lower areas generated by potential weather events (very heavy rains, tropical cyclones, extra tropical rainfalls and combinations of migratory anticyclones, cold fronts and the proper periphery of migratory anticyclones) is shown on the map of Fig.3. If there was a Force 5 hurricane, the combination of events would be the most unfavorable.

The critical flood zone (primary) coincides with the low areas near the initial development part of the city, close to the mouth of the channel that provided access to the bay. The wharfs of the first port are also included in this area. This zone represents very valuable urban fabric in its architectural, historical and heritage components. The outline of this primary urban sector provides an approximation of the original line coast.

Out of a total of 24 rammed-earth buildings identified around the town, ten of them or 40% of the total are located in the flood zone. Of these, four are located in the most vulnerable primary sector. In each case, research needs to occur, to review if there is lime stabilization, in order to pinpoint the most vulnerable buildings.
