FROM THREAT TO OPPORTUNITY: THE CASE OF BAM, IRAN

Eskandar Mokhtari Taleghani, Rasool Vatandoust, Glavije Amirjamshidi

Theme 2: World Heritage Earthen-Architectural Sites, Natural Disasters and Climate Change

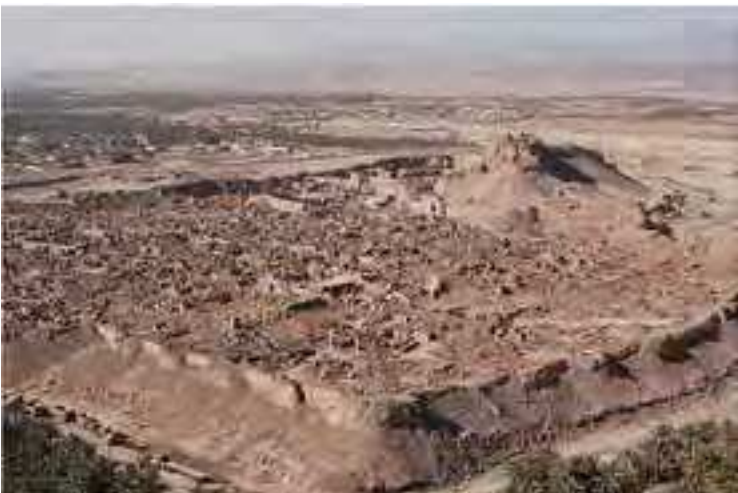
Fig.1 The Bam citadel in 2004 after the 2003 earthquake (credits: RPBCH, 2011)

At first assessment, the earthquake damage was estimated to be well over 80%. The Bam citadel appeared to be a mass of ruins; however, subsequent analyses and surveys, revealed otherwise. These surveys were based on the comparison of the volume of the earthen structures before and after the earthquake. For example, the volume of the standing outer-boundary wall of the citadel before the earthquake was 168,570 cubic meters. This volume decreased to 151,319 cubic meters after the earthquake. Thus, the volume of destruction was

17,250 cubic meters, or in other words, 10.33% of the wall. This can also be calculated holistically based on the volume of the entire citadel as a complex (the boundary wall, the important buildings described in the pilot projects, government's quarter and residential areas). In this case, around 195,935 cubic meters were destroyed; this amounts to about 23.7% of the entire volume of the buildings (Keramatfar, 2008).

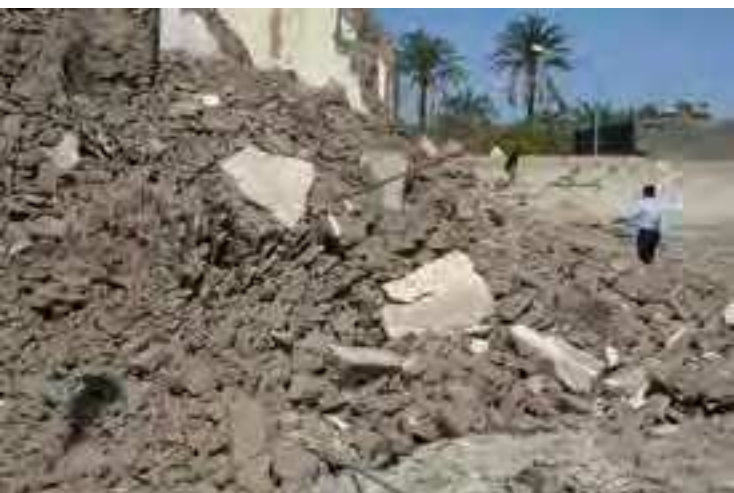
Fig.2 The city of Bam after the earthquake (credits: G. Amirjamshidi, 2004)

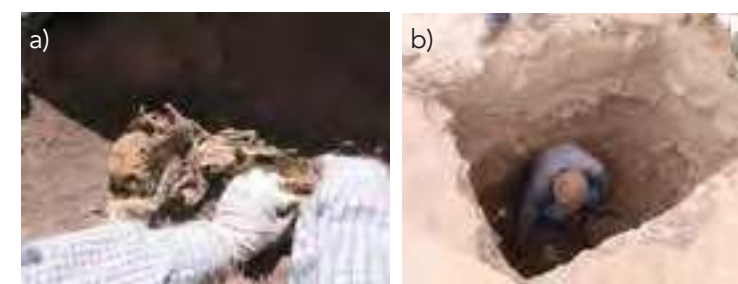
Fig.4 (a) Excavation at the Bam citadel (credits: RPBCH, 2011)
(b) Excavation of roads at the citadel (credits: G. Amirjamshidi, 2004)

Archaeological studies that were carried out from the first day after the earthquake started to reveal thousands of hectares of valuable historical landscape with numerous sites, some as near as just one kilometer from the citadel. The archaeological artifacts around Bam had remained undiscovered for millennia
