PROTECTION OF AN EARTHEN-ARCHAEOLOGICAL SITE: A COLLABORATIVE EFFORT BETWEEN COMMUNITY AND EXPERTS, CHILE

Theme 3: Documentation, Conservation and Management of Archaeological Sites
Keywords: Archaeology, consolidation, structures, management

CONSERVATION OF RAMMED-EARTH STRUCTURES: THE HISPANO-COLONIAL ARCHAEOLOGICAL SITE OF SANTA FE LA VIEJA, ARGENTINA

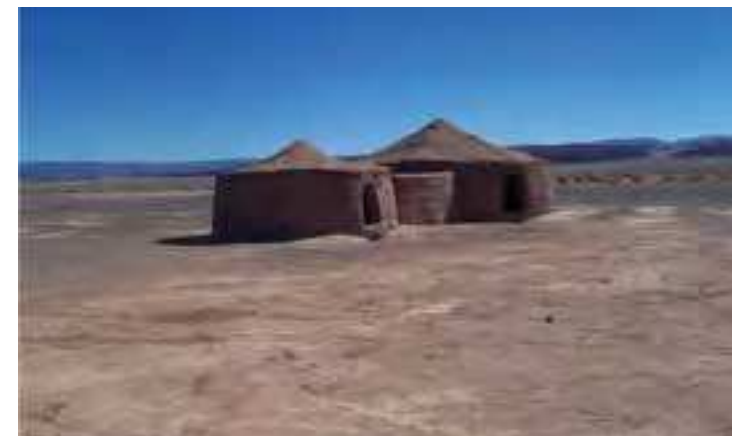
Fig.2 Replicas of two village dwellings built as a conservation practice site (credits: Monica Bahamondez)

In 1982, an area was chosen, 30m distant from the last vestiges of walls of the site, to construct a polygon for testing, which consisted of exact replicas of the structures number 2 and 3, with their linking walls. A hypothetical roof was also added to recreate the conditions inside the rooms. Here it was possible to accomplish various types of measurements and tests with conventional conservation materials, as well as with various consolidants. The research station on site, included meteorological-measurement equipment that allowed recording the prevailing environmental conditions at the site (Muñoz and Bahamondez, 1990).

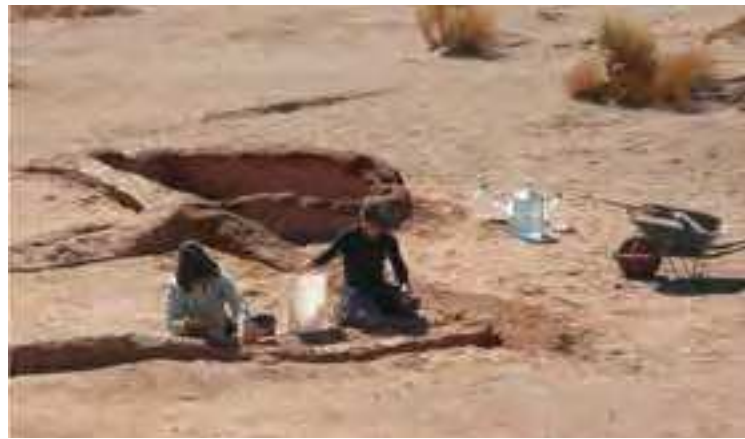
Fig.3 Removal of salt-contaminated first coating layer. (credits: Monica Bahamondez)

Considering the current condition of the top of the walls, the extent of damage caused by the exfoliation of layers and efflorescence of salts, of the first step was to remove material irreversibly degraded and unrecoverable. This task was achieved through the careful work of constant evaluation of the materials affected in varying degrees by erosion and salinity. The removal of the damaged layers was limited to the level of

the depth of loose saline material that no longer had the ability to adhere to the wall. The tops of the walls were cleaned until the original material was found, which still retained in good condition and consolidation. With a sound substrate, it would be possible to reintegrate new patching material.
