CONSERVATION OF RAMMED-EARTH STRUCTURES: THE HISPANO-COLONIAL ARCHAEOLOGICAL SITE OF SANTA FE LA VIEJA, ARGENTINA

Luis Maria Calvo

Abstract

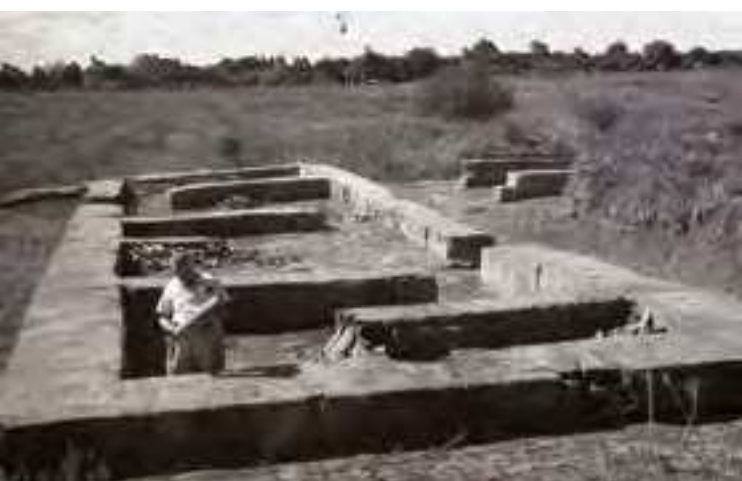
Fig.2 Archaeologist Agustín Zapata Gollan with the remains of rammed earth walls of a house he excavated (credits: Ethnographic Museum in Santa Fe, near 1952)

The foundations and lower parts of the walls remain. Its thickness depends on the type of building, which can vary between three-quarters of a measuring rod in the houses (approximately 60 cm), up to one-and-a-half measuring rods in churches (approximately 120 cm). The original roofs were of straw or terra-cotta tile, and only fragments of the latter associated with the archaeological structures are preserved.

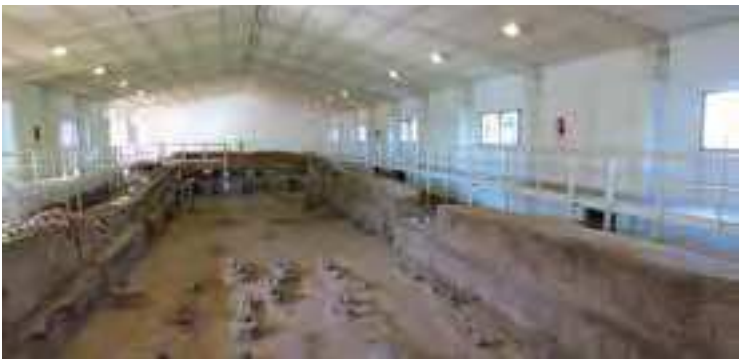
Fig.3 Protective shelter for the church of San Francisco built in 1973 (credits: Luis Maria Calvo, 2005)

- Enclosures with brick walls, sliding windows, and a wooden structure covered with aluminum sheets were erected. They existed until 1973.
- New structures were built by 1973, similar to large sheds that consisted of reticulated metal structures, brick-wall enclosures and sheet-metal roofs. On the exterior, concrete irrigation ditches were built to manage rainwater.

- These structures have effectively protected the rammed earth remains. Three decades after Rodríguez Camilloni formulated

this assessment, it is recognized that the wall structures have survived in reasonably good condition.

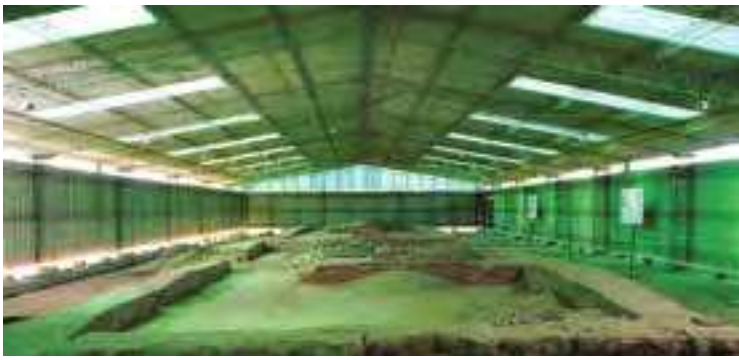
Fig.4 Protection of the Gonzalez de Ataide house according to the prototype designed by H. Rodriguez Camilloni (credits: Jorge Anichini, 2005)

prototype (Rodriguez Camilloni, 1987, p.9), whose proposed design consisted on:

- A semi-open pavilion, equipped with a gabled roof with side gutters and downspouts connected to the general drainage of the site.
- A perimeter fence consisting of fiber-cement panels that serve as windbreaks but allow ventilation, by leaving open spaces at the bottom and at the top.
- The perimeter fence also provides surfaces for mounting explanatory signs and graphic reconstructions of the ruins.
- The course for visitors is accomplished on one side of the ruins (it can also be around the perimeter), and consists of a tile floor directly placed on the existing floor.

The purpose of these structures is to nullify the main causes of deterioration (wind action and rain erosion), to control the access of visitors, and in turn to allow a museographical display. For two decades the Conservation Plan was the guideline for all actions that were undertaken at Santa Fe La Vieja. In the 1990s, six protective structures were built following the prototype designed by Rodriguez Camilloni, one for the Council and five for the houses (González de Ataide, Fernandez Montiel, Paez, Cifuentes and Garay).
