# THE STABILIZATION, CONSERVATION AND PRESENTATION OF MONUMENTAL MUD-BRICK ARCHITECTURE: THE SHUNET EL ZABIB IN EGYPT

Anthony Crosby

Abstract

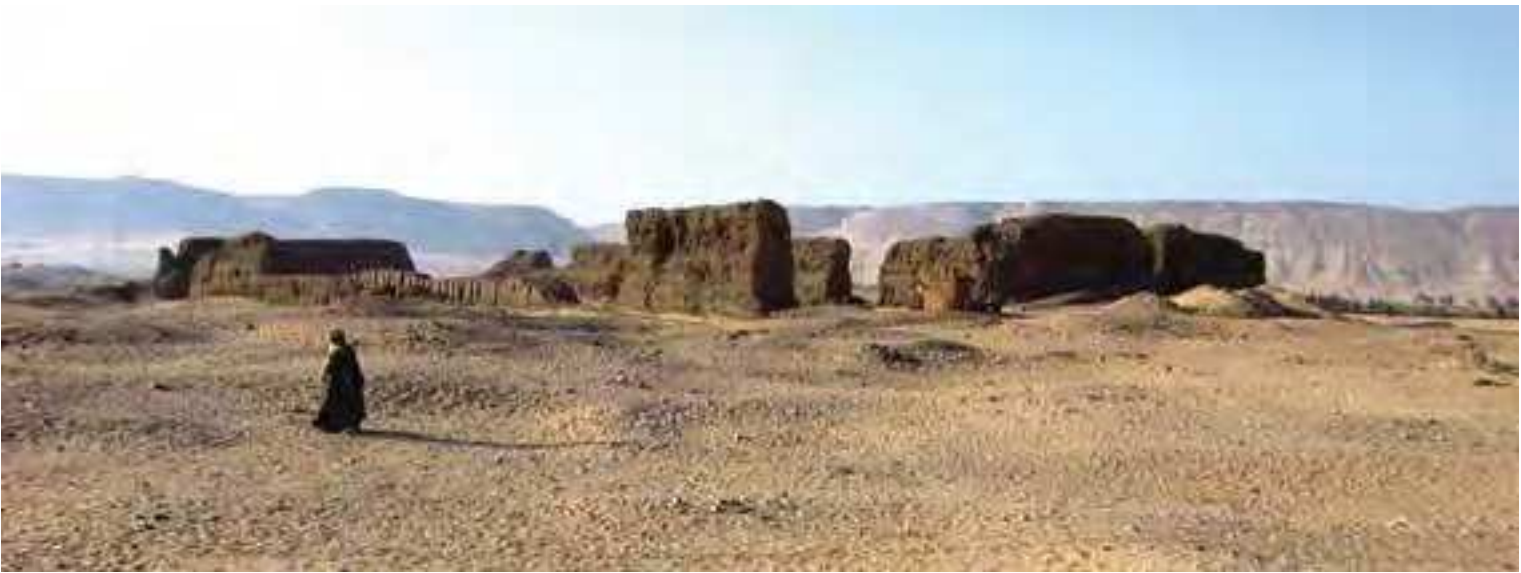
Fig.1 Shunet el Zabib, the funerary enclosure of Khasekhemwy from the north, with mud brick walls 11 meter high (credits: Anthony Crosby, 2001)

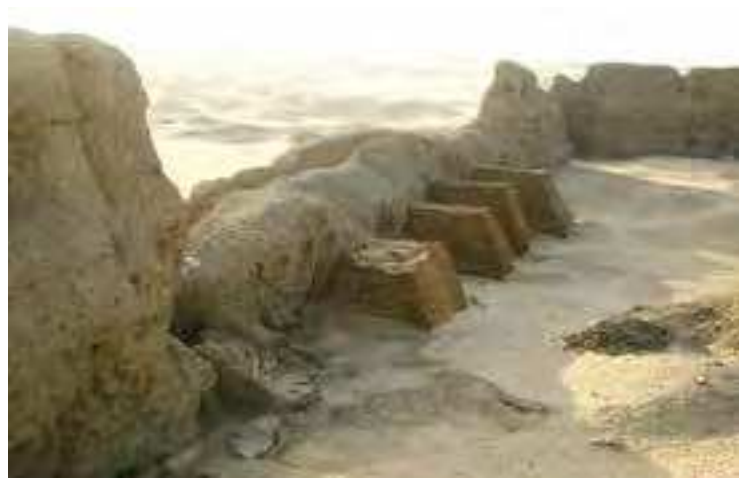
Fig.2 Large sandbag buttresses were constructed in 2001 to support the east enclosure wall (credits: Anthony Crosby, 2006)

The first stabilization action was the construction of large sandbag buttresses along the interior of the east enclosure wall in 2001. This entire wall section is much lower than the other enclosure walls, but had been severely undercut by animals and 19<sup>th</sup>-century invasive archeological excavations. Many sections of this wall were in immediate danger of additional loss. One large structural crack was identified as characteristic of the failure pattern of the entire wall, and it was cleaned and repaired with mud mortar and horizontal reinforcement.

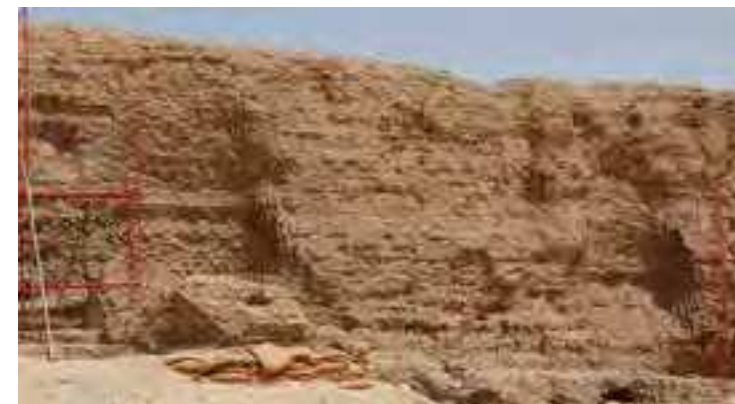
Fig.3 The west enclosure wall showing the completion of the stabilization of two collapsed areas where Coptic cells existed (credits: Anthony Crosby, 2006)

The most severe conditions of unsupported upper walls has resulted from the construction of the Coptic cells and their eventual collapse and the loss of foundation sand from the east enclosure wall from mid-19<sup>th</sup>-century archeological excavations. These conditions have required the greater interventions in the form of replacing much of the loss materials from the Coptic-cell collapse and the construction of a mud-brick foundation system along the interior of the east enclosure wall.

The large collapsed areas were partially reconstructed with mud bricks following the same coursing as the original. The reconstruction of a collapsed Coptic cell was not completed flush to the existing wall, but recessed to indicate that a cultural feature existed. Geogrid was used as horizontal reinforcement at the approximate same vertical spacing as the original reed mats.

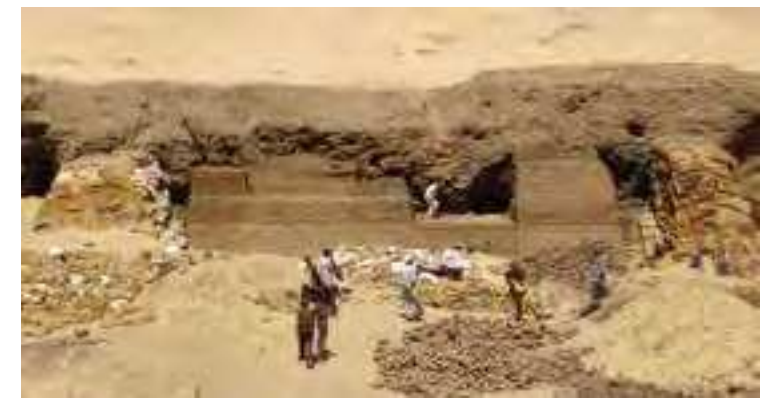
Fig.4 East enclosure wall showing the process of constructing the mud-brick foundation system (credits: Anthony Crosby, 2010)

Mid 19<sup>th</sup> century excavations extended along the east wall were approximately 3 meters deep – they were never backfilled. Sand began to move from under the wall into the trench, and the lower mud bricks followed the sand into the excavation trench. A new foundation is being constructed to provide the missing support for the east wall. It extends out from the original wall plane approximately 1 meter and extends 1 meter below the original base of the wall. The new sections are completed between the sandbag buttresses, and once completed, the buttresses are removed and the two sections are connected with a continuation of the foundation.

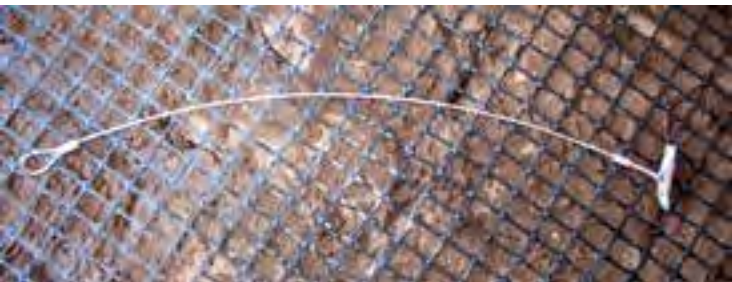
Fig.5 Aluminum wedges attached to stainless-steel cables used to attach geogrid to mud brick walls (credits: Anthony Crosby, 2010)

The new mechanical ties are similar, but much simpler in design and installation. They consist of aluminum wedges attached to stainless-steel cables. Holes are drilled and the aluminum wedges are driven into the historic mud bricks. Tension is put on the cables and the aluminum wedges are set perpendicular to the axis of the drilled holes, locking them in place. The cables are then attached to the geogrid.

These proved effective as they can be installed with minimal supervision and provide adequate pull strength of > 140 kilos.

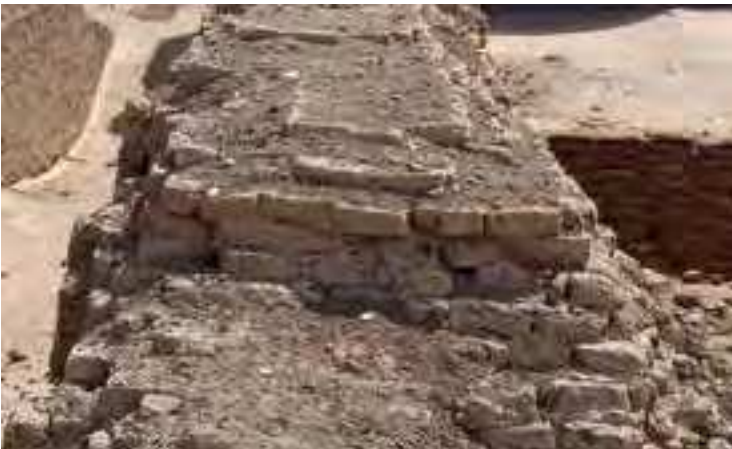
Fig.6 Comparison of mud-brick protective cap and existing wall top (credits: Anthony Crosby, 2005)

It is estimated that the tops of the walls, unaffected by more traumatic loss, have eroded approximately 3 meters, vertically, over the 4,700-year life of the structure. The upper most exposed mud bricks are friable and will continue to erode, albeit, extremely slowly, because of the lack of significant rainfall. While a lower priority than the reconstruction of missing structural elements, capping using unstabilized mud bricks is one of the important treatment interventions. The tops of the walls are prepared by removing loose, friable materials and new mud bricks are placed in the general contours of the existing walls. The contouring of the cap and the distribution of additional loose soil result in a character that evokes the character of the pre-treated wall tops.

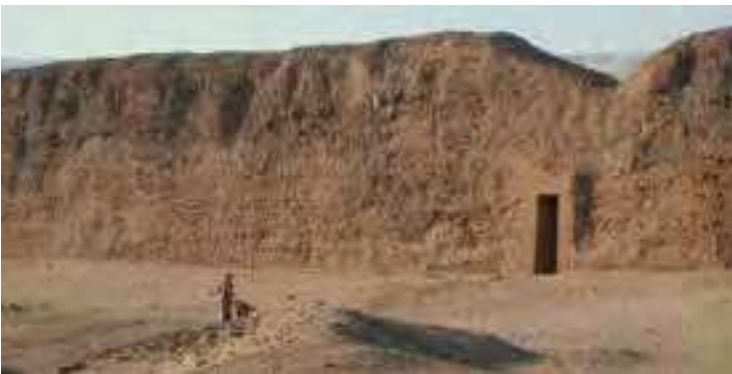
Fig.7 The west enclosure wall from the north after completion of the west gateway stabilization and restoration (credits: Anthony Crosby, 2010)

The important structural stabilization of the walls at the original gateways into the Shuneh presented an important presentation issue. The missing mud-brick sections had to be rebuilt to support failing end walls and the decision was made to include an opening into the Shuneh through the new masonry. After much deliberation a decision to partially restore the west gateway to its historic appearance was made. The existing footprint of the gate was known from archeological evidence and additional research to determine the appropriate height and other details was undertaken. The results from the combination of research and physical evidence is a gate opening approximately 3 meters high with exposed beams and lintels; the proportions are based on the royal cubit. The wall surfaces immediately adjacent to the opening are restored to their original plane, but immediately blend to the color, texture and wall planes of the existing mud-brick masonry of the Shuneh.

of the conservation treatments. In addition, the presentation solutions have been developed and incorporated into the conservation specifications with the completion of the partial restoration of the west gate. In future seasons, the work will continue with the stabilization of the remaining tall walls, the filling of voids and the stabilization of the other gateways. Eventually, all of the walls will be capped with a sacrificial layer of mud bricks. The sacrificial bricks will ultimately erode, but in the meantime the original bricks beneath will be protected.
