DEVELOPING AN EMERGENCY-CONSERVATION PROGRAM FOR THE CULTURAL HERITAGE OF ABU DHABI, UNITED ARAB EMIRATES

Aqeel Ahmed Aqeel, Amel Chabbi, Hossam Mahdy, Ali Malekabbasi, Benjamin Marcus, Salman Muhammad Ali

Theme 7: Ancient/Historic and Innovative Solutions for Damage Prevention and Performance Improvement
Keywords: Rapid assessment, emergency, conservation, planning

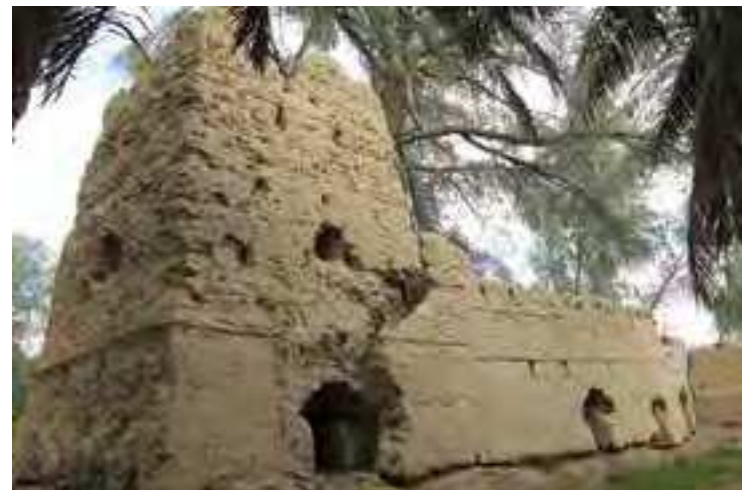
Fig.1 Mohammed Bin Bidowah Al-Darmaki House and Bin Shehail Al-Mottawa Al-Dhahiri House before emergency conservation (credits: Benjamin Marcus © ADACH, 2010)

The buildings included in the program are mostly roofless earthen 'ruins'. The palm-wood roof beams and lintels, susceptible to termite infestation and weathering, have collapsed, leaving interiors filled with debris that were causing pressure on the walls. The tops of the adobe walls were eroded from wind and rain, while rising damp and salts in the ground were causing basal erosion. Erosion of the wall base, known as 'coving', quickly leads to structural problems such as cracks, lateral movement and eventual collapse. The sites are typically located in cultivated oases where water damage is prevalent or in underdeveloped areas where they are used as ad-hoc housing for laborers or garbage dumps. At the beginning of the program, nearly all of the 36 sites were unmanaged, or without fencing, signage or visitor control.

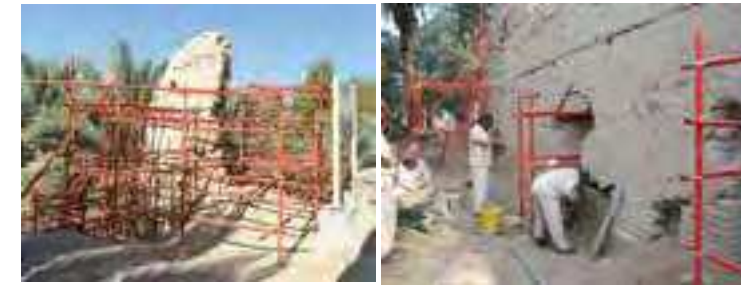
Fig.2 Al-Suroor Southern House after emergency stabilization (credits: Salman Muhammad © ADACH, 2011)

Fig.3 Repair of coving at Mohammed Bin Bidowah Al-Darmaki House (credits: Ali Malekabbasi © ADACH, 2010)

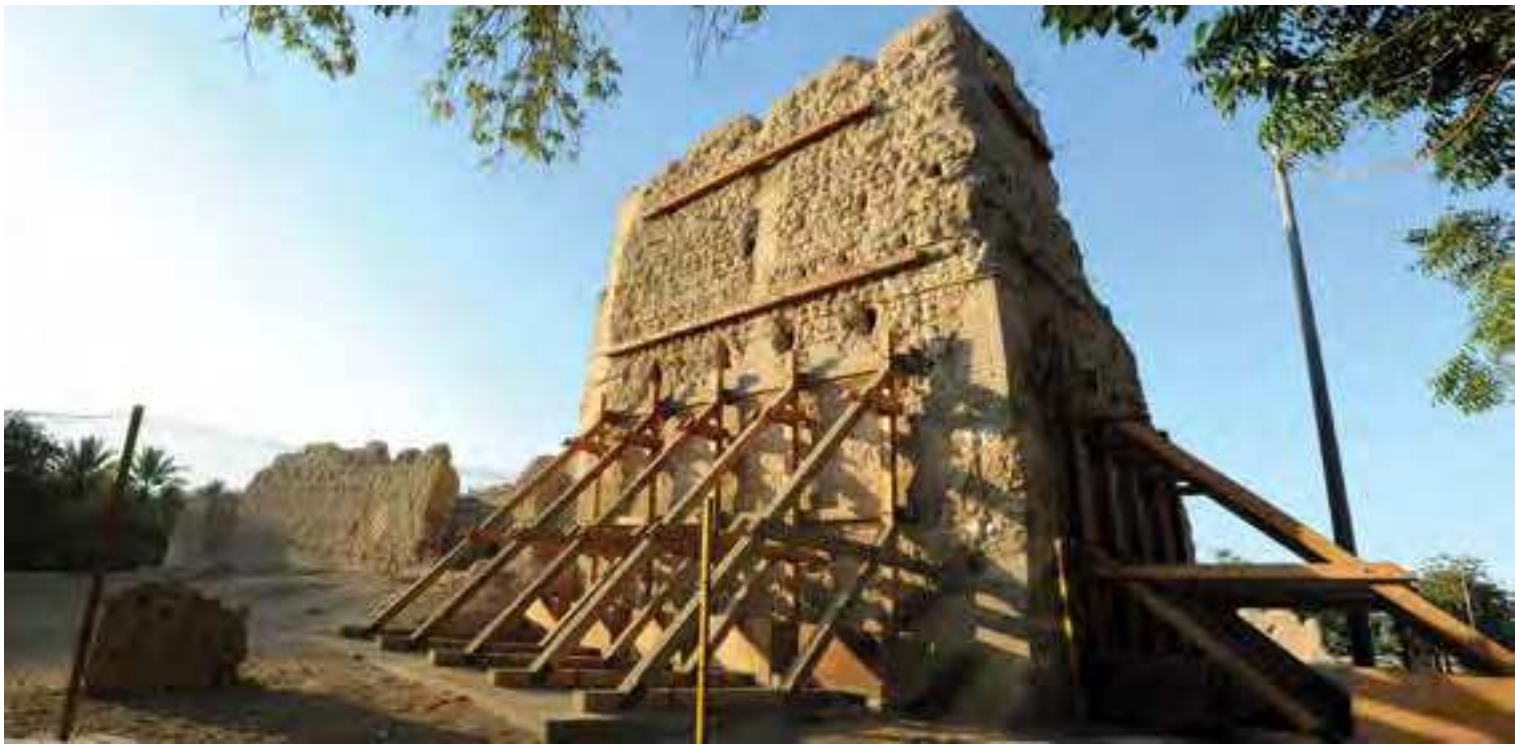
Fig.4 Abdullah Bin Salem Al-Darmaki House showing steel pinning and shoring (credits: Salman Muhammad © ADACH, 2011)

Some of the buildings included in the EC program were restored prior to the establishment of ADACH, and their original fabric is heavily altered. In this case, techniques that replicate vernacular-construction traditions, such as re-rendering with new earth plaster or replacing deteriorated lintels or roof beams with new wood were considered appropriate. Other sites, with a higher degree of material integrity, have been treated with a more archaeological approach. Intervention is kept to a minimum and the focus is on reversible treatments, such as pinning with steel rods or supporting with scaffold.

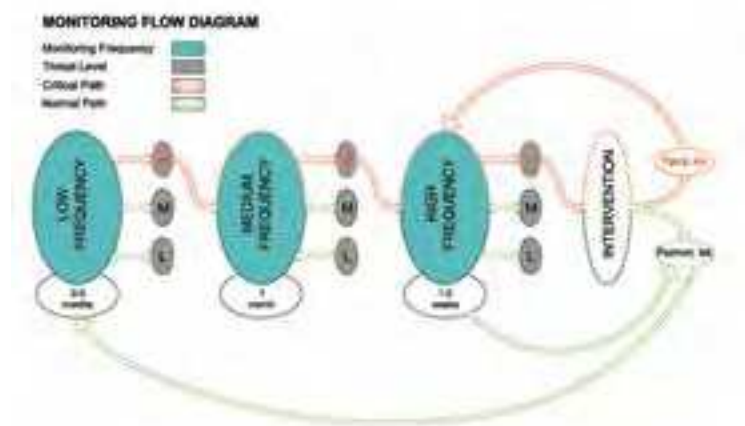
Fig.5 Monitoring flowchart (credits: © ADACH, 2011)

monitored, such as inherited building anomalies, permanent building features, short-term intervention methods to support conservation, and long-term intervention methods. This data was compiled into a matrix and paired with the appropriate tools and procedures that ranged from simple gypsum-crack monitors to laser-reflective targets for tracking structural movement and erosion. A flowchart was developed based on this matrix to describe the procedure to follow with regards to visit frequency and level of threats.

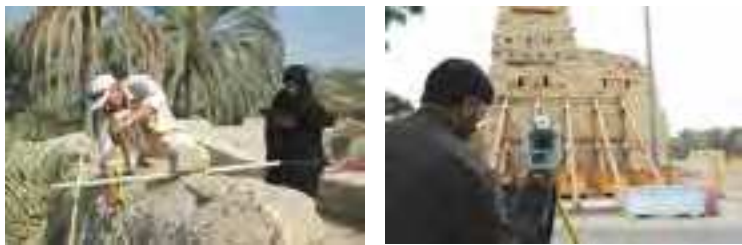
Fig.6 and fig.7 Documentation of Jimi Walls and monitoring of Abdullah Bin Salem Al Darmaki House (credits: Salman Muhammad © ADACH, 2010 - Ali Malekabbasi © ADACH, 2011)
