STANDARDS FOR THE CONSERVATION AND RECOVERY OF EARTHEN HERITAGE, PERU AND CHILE

Julio Vargas-Neumann

Theme 8: Charters, Standards and Guidelines for Heritage and Construction

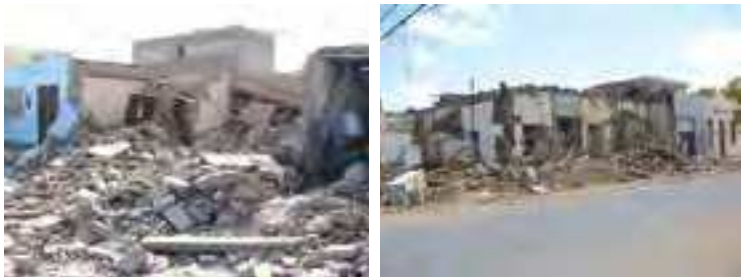
Fig.1 Collapsed houses during the earthquakes of Pisco, Peru, 2007 and Maule, Chile, 2010 (credits: J. Vargas-Neumann, 2007 y 2010)

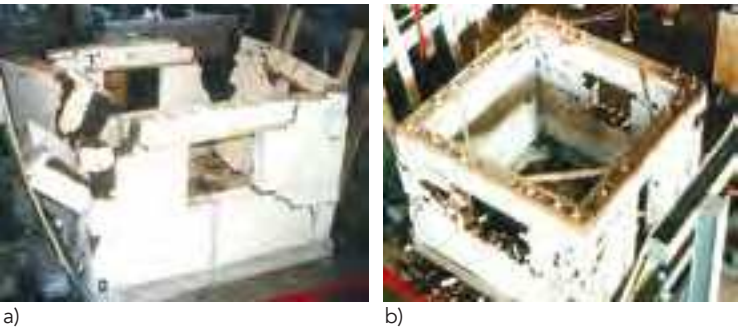
Fig.3 Tests of adobe modules on vibrating table a) Unreinforced module; and b) Reinforced module (credits: Joop den Uyl, file PUCP, 1982)

The main conclusion drawn was that when faced with a severe earthquake, unreinforced structures collapse (Fig.3a). The interior reinforcement of horizontal and vertical reed plus an upper wooden collar beam prevents separation of the walls and maintains some integrity during repeated severe unidirectional earthquakes (Fig.3b), providing the option for future repairs.

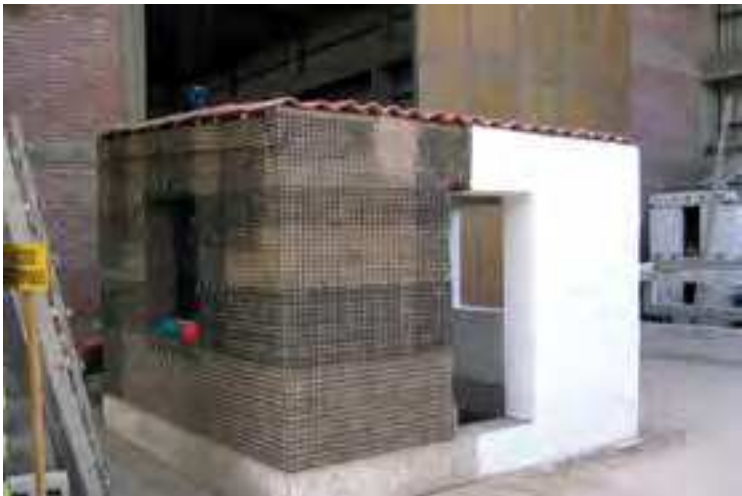
Fig.4 Module reinforced with synthetic mesh or geogrid with total reinforcement and coating of half of the module (credits: File PUCP, 2007)

Later, another line of research began to develop more efficient reinforcement systems to avoid sudden failures using industrial materials. Synthetic geogrid reinforcing has proven to be very effective. The geogrid must completely cover both sides of the walls and to be fixed to the upper collar beam of the walls.

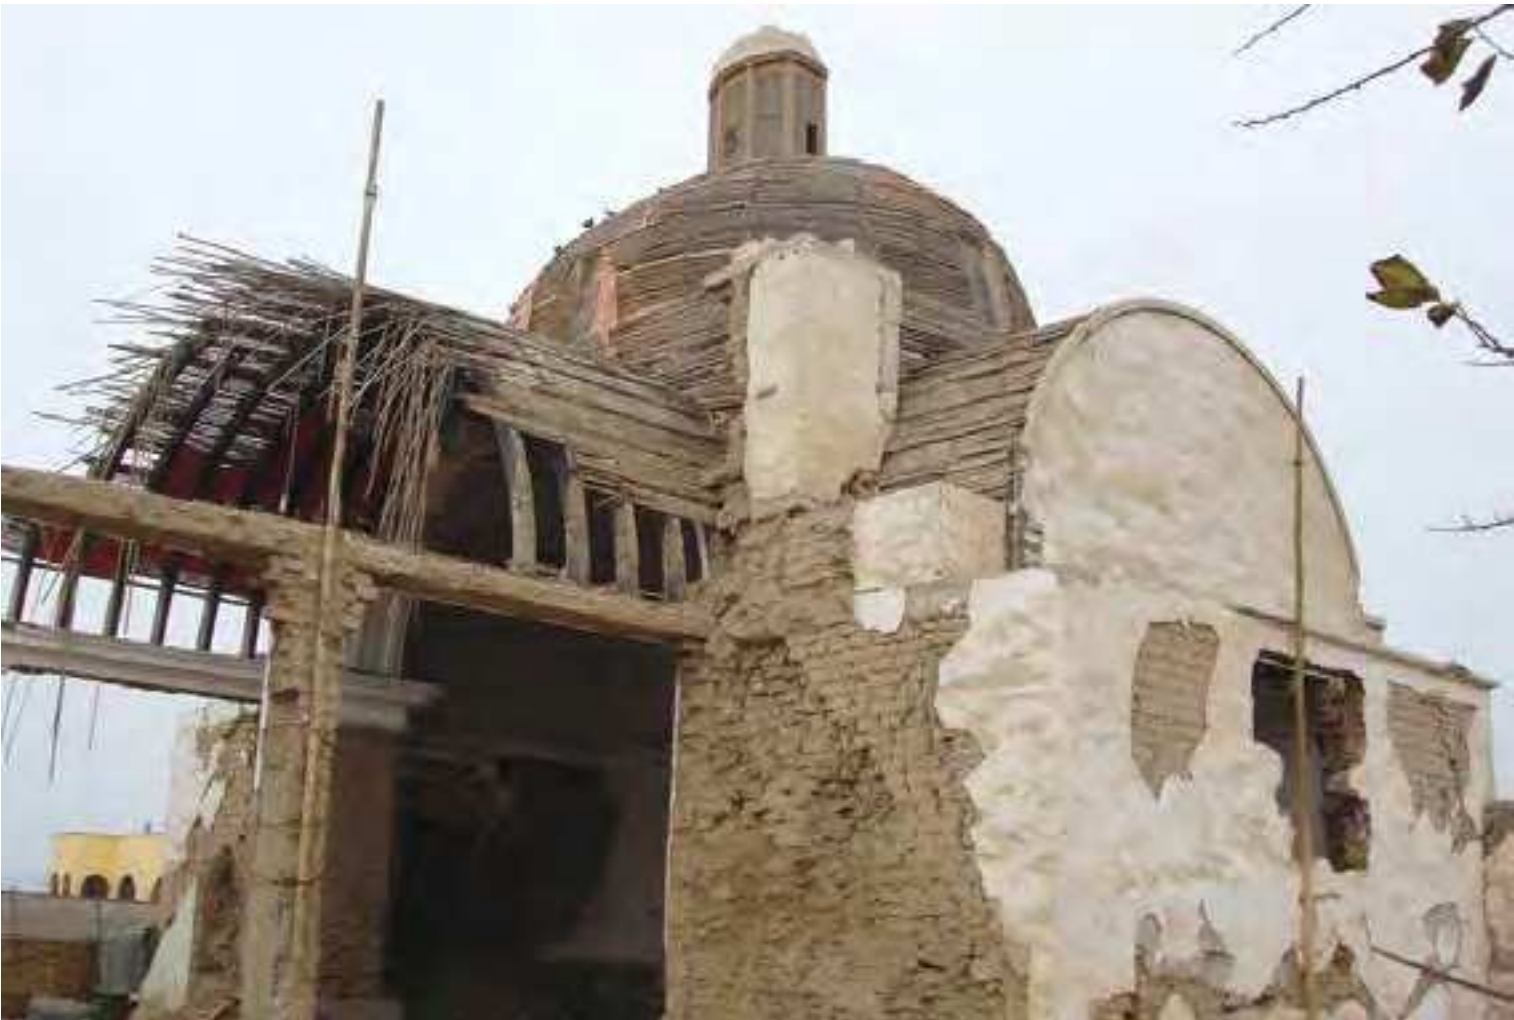
Fig.5 Avoid strengthening with reinforced concrete beams and columns, because they aid in collapse instead of protecting adobe walls, as in this example of the church of San Luis de Canete, damaged during the Pisco earthquake in 2007 (credits: J. Vargas-Neumann, 2007)

The *Peruvian Standard* specifies the allowable stresses for adobe masonry. It also specifies that the walls should be well connected. The vertical bracing can be cross walls, buttresses or reinforced concrete columns. The upper collar beams, made of wood or reinforced concrete, are the horizontal reinforcement and must be applied to all walls. However, the current revision to the Standard does not recommend reinforced concrete columns or beams because of their difference in hardness and rigidity with earth.

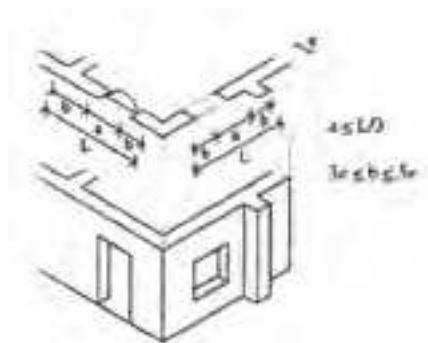
Fig.6 Specifications for wall openings; the relief of the buttresses must be equal to “b” (credits: Norma NTE Adobe, 1999)

The walls must comply with certain geometric conditions to ensure good seismic behavior. The maximum length between wall bracing should be 12 times the thickness of the wall, and the openings must be central and small.
