INTERNATIONAL HERITAGE CONSERVATION PRINCIPLES
IN EARTHQUAKE ZONES, JAPAN

Kanefusa Masuda, Olga Keiko Mendoza Shimada

Theme 8: Charters, Standards and Guidelines for Conservation of Heritage and Construction
Keywords: Lima Declaration 2010, Venice Charter 1964, Nara Document 1994, World Heritage

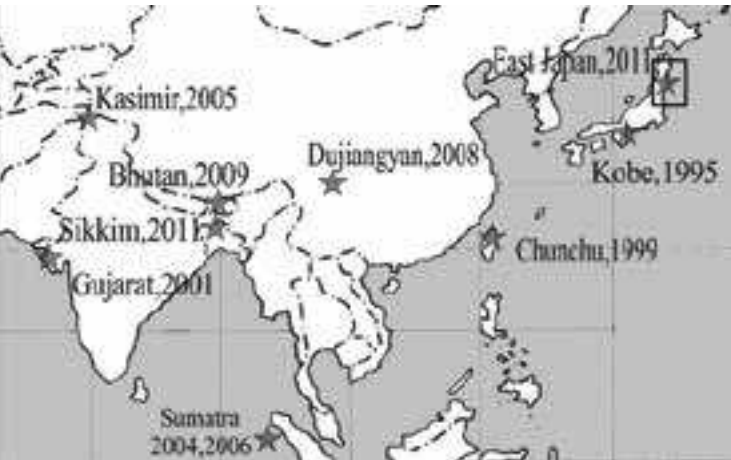
Fig.1 Recent big earthquake disasters in East and South Asia (credits: Mendoza Shimada, 2011)

In these decades, Eastern and Southern Asia region have experienced many big earthquake disasters and many cultural resources, including several World Heritage sites, were affected. In China, for example, Dujiangyan, inscribed in 2000, was badly damaged by the earthquake in 2008. The Old Town of Lijiang was listed in 1997, immediately after a big earthquake damage in 1996. The town has been impacted five times from earthquakes in the 20th century, including 1933, 1951, 1961, 1977, and 1996. Periodic reconstruction here is a long cultural tradition (ICOMOS-Japan, 2011).

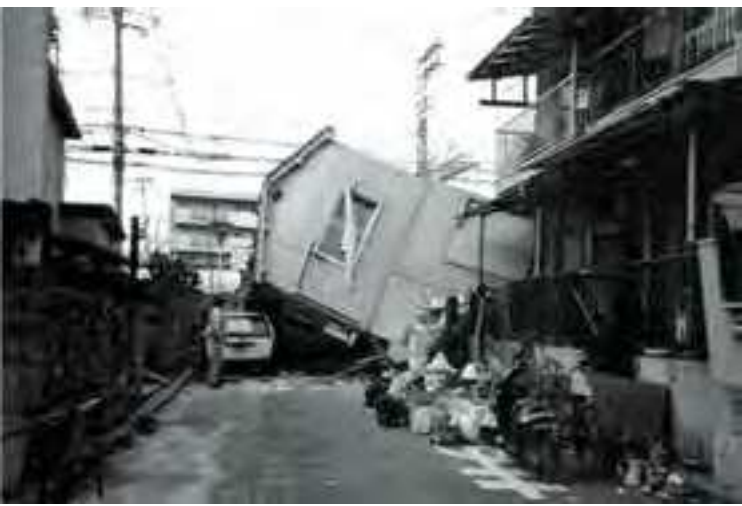
Fig.3 Kobe 15th Mansion (protected heritage) destroyed by Kobe Earthquake, M.7.3, January 17, 1995 caused liquefaction of the ground (credits: K.Masuda 1995)

The 15th Mansion was constructed in the foreign settlement in 1881 as the US Consulate office and it was built in American east-coast style, with timber-frame structure and brick wall. In 1989, it was designated as an Important Cultural Property building by the central government. The owner was a private company, and constructed a new high-rise office tower next to the historic protected building. As it is located in the central downtown area, the building had been used as a Chinese popular restaurant.

Fortunately, the collapse of 15th Mansion did not kill nor injure anybody, because the earthquake occurred in the very early morning. But if it had happened at lunchtime, for example, some 50 people might have been killed by the collapse of this historic structure. If anyone was killed in this building, the government would not have been able to escape from its responsibility. During the Kobe earthquake, hundreds of historic protected buildings were damaged, but none caused death or injury. Several historic buildings collapsed as a result of this strong earthquake; however, 15th Mansion was the one most severely damaged. The central government started immediately to make the recovery plan of cultural heritage, and the reconstruction of 15th Mansion became a symbol of the cultural heritage recovery projects.

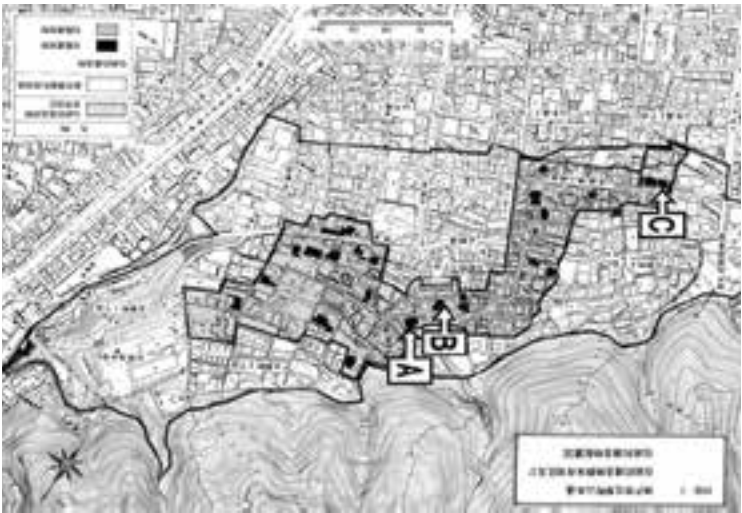
c) The Kobe-townscape conservation district, with many Western-style rich houses, was also damaged by Kobe Earthquake 1995.

Another big recovery project was in the Kitano foreign-residential area, which is protected as a townscape conservation district by the central government since 1980. In a rather small area of 9.3 ha, 65 protected buildings are listed, and many of them were partially damaged by the earthquake, especially at their heavy brick chimneys.
