# SEISMIC RESISTANT ADOBE WALLS AND EARTHEN FRAMEWORK VAULTS AT THE COMPAÑIA DE PISCO CHURCH IN PERU

Pedro Hurtado Valdez

Theme 7: Ancient/Historic and Innovative Solutions for Damage Prevention and Performance Improvement  
Keywords: Dome, earth, seismic

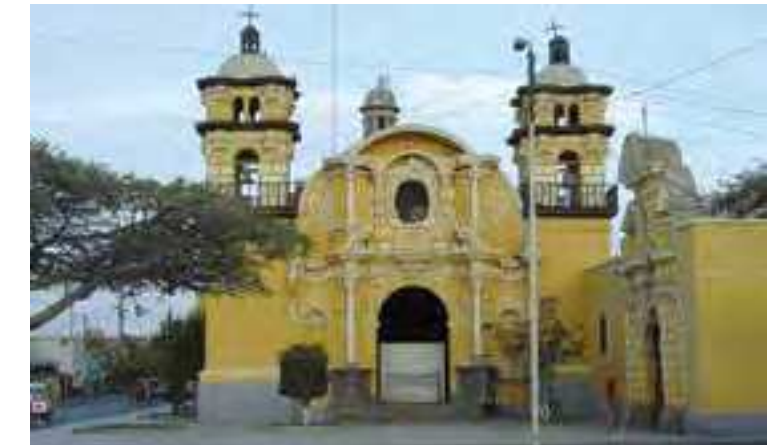
In 1942, a strong submarine movement, near Pisco, caused by an earthquake of 8.1 magnitude was recorded, but the church withstood it. In 1949, a new earthquake affected part of the temple, forcing maintenance work, although those in charge of the work caused the collapse of part of the vault, and

even damaged the front wall. The temple became a repository for the construction materials left after the cessation of the work. The building was once again vacant until 1960, when the National Council of Conservation and Maintenance of Historic and Archaeological Monuments performed restoration work on the church. Further interventions incorporated cement coatings within the structure, while the streets were asphalted and the enclosures and the small square opposite the church paved. In 2003, the Municipality performed an intervention on the façades and the base of the walls, sealing cracks and coating detachments with cement and latex paint.
