AL-TURAIK DISTRICT OF AL-DIR’YAH, SAUDI ARABIA: WORLD HERITAGE SITE FACING PERIODIC EXTREME WEATHER EVENTS

Pamela Jerome, Mohammad Yosof al-Aidaros, John Hurd

Theme 2: World Heritage Earthen-Architectural Sites, Natural Disasters and Climate Change  
Keywords: Al-Dir’iyah, violent rain, sand storms, risk preparedness, disaster response

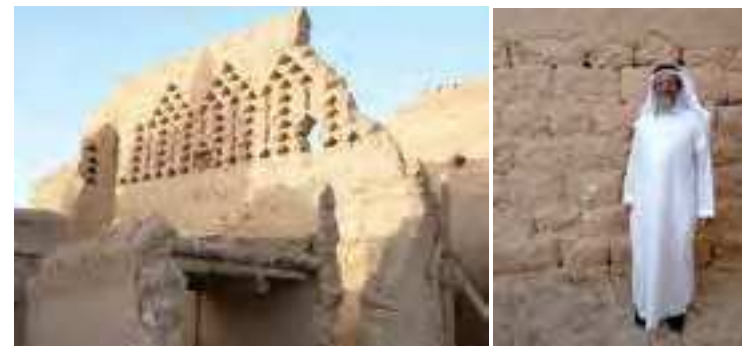
Fig.2 A wide variety of historic Najdi architecture is found on the site (credits: Pamela Jerome, 2011)

Fig.3 One of the authors standing next to a high stone foundation for scale. These provide traditional flood protection for the mud-brick superstructures (credits: Pamela Jerome, 2011)

The traditional architecture was designed to withstand the effects of floods by having tall stone foundations. However, the capacity of the recently installed plumbing infrastructure needs to be able to accommodate extreme events, including 100-year floods. In addition, provisional measures may be required, such as temporary backfilling in advance of the ‘rainy’ season, typically the spring and fall on the Arabian plateau. In general, backfilling of excavation soundings will both clarify presentation and prevent destruction by ponded water.

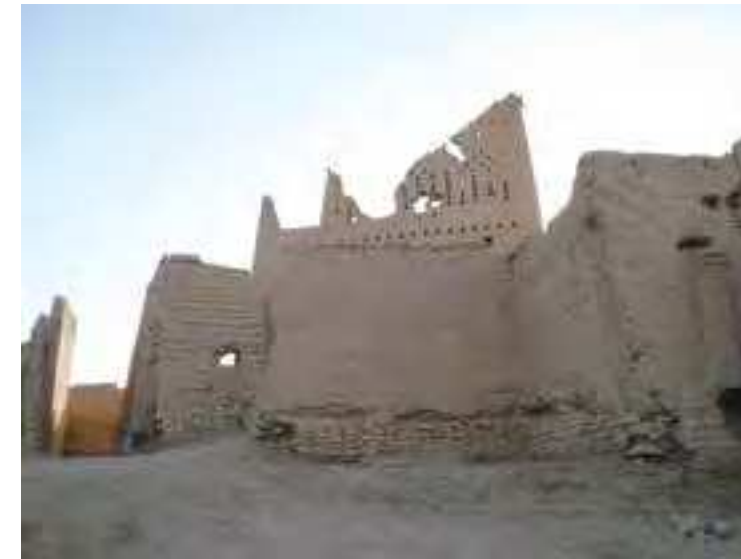
Fig.4 Textures vary at the site and are an important aesthetic that should be protected (credits: Pamela Jerome, 2011)

- Appreciate and document the principal qualities of the historic architecture and archaeology by recognizing the subtle textural languages of the structures on site. During the workshop's inspection, at least four types of earthen construction were noted, and no less than four general styles

and textures of plaster finishes; these possibly represent and reflect the period at which a structure was first built. It is important to guard against the use of unified styles of plastering, color and texture. A unified pattern of color and texture will lead to a bland and monotonous appearance. Therefore, each wall, internal and external, of each structure should adopt a texture and color unique to the historic finishes observed in situ.
